Contentnea Metropolitan Sewerage District

Hurricane Matthew
October 8, 2016

Chuck Smithwick
District Manager, CMSD

A Look Back
at Hurricane
Matthew

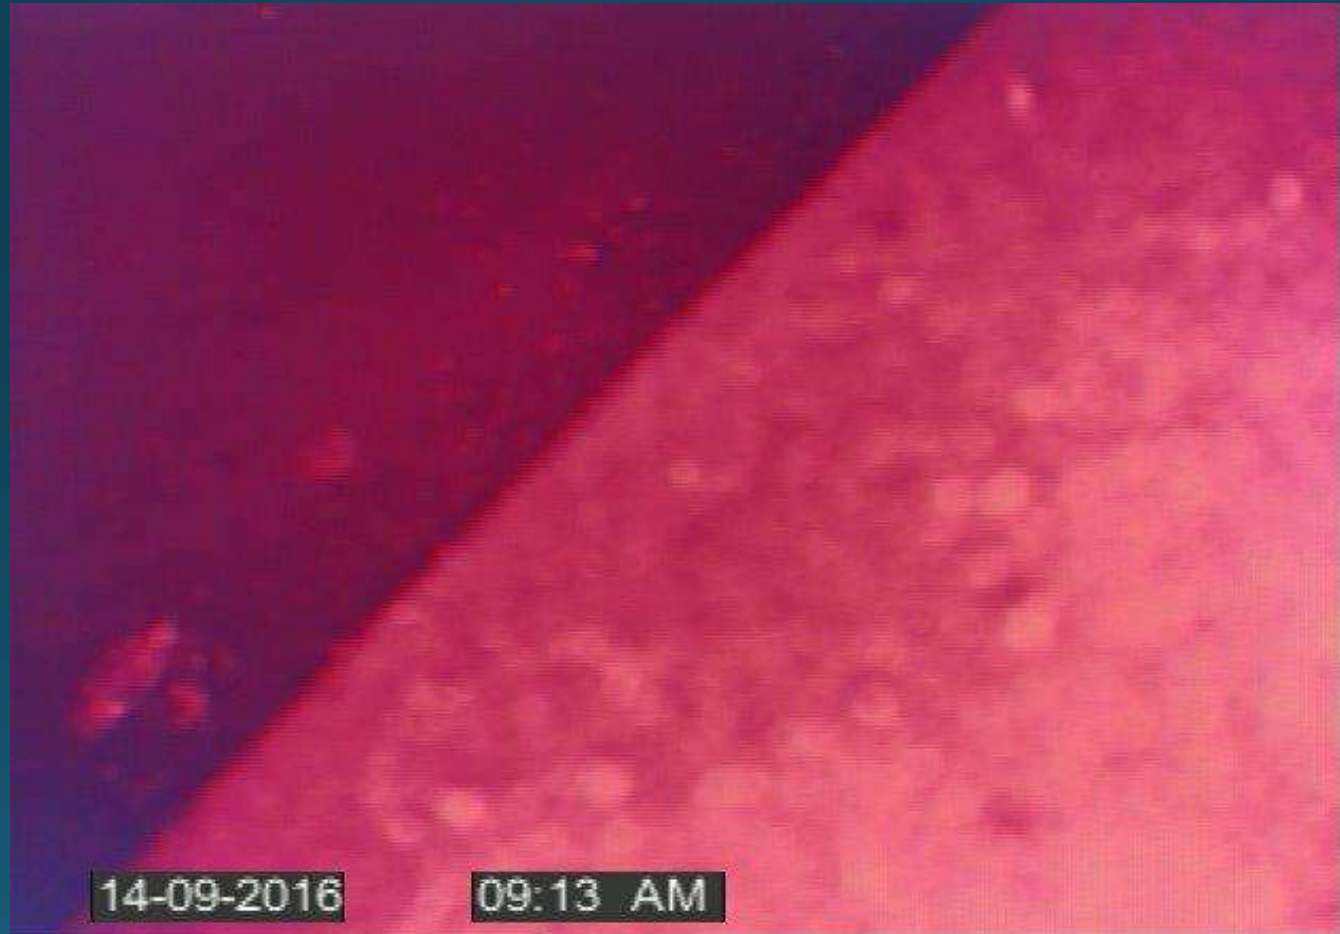
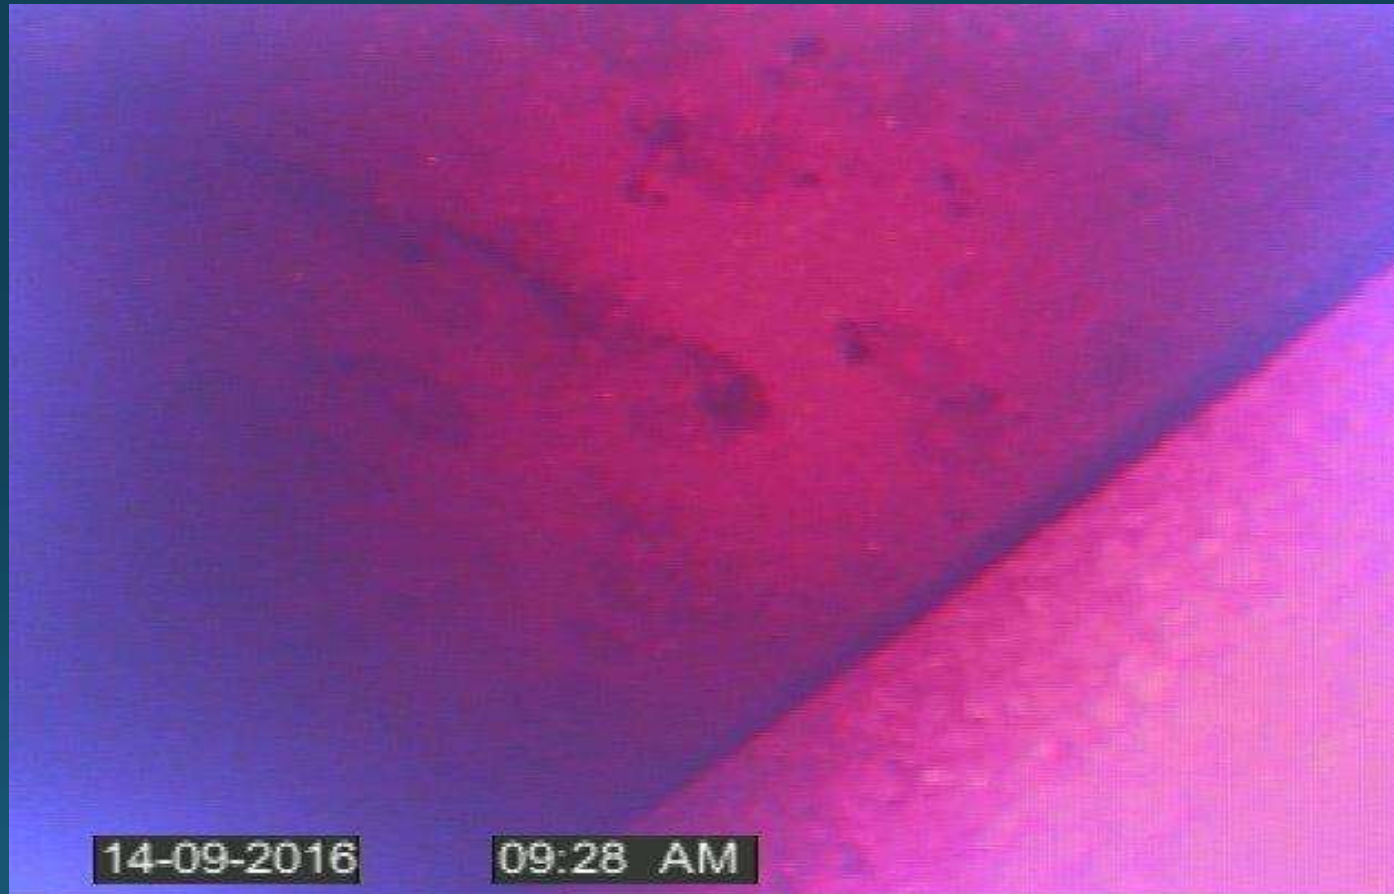
2,000 gal belly tank @ WWTP

Sludge Yes <input type="checkbox"/> No <input checked="" type="checkbox"/>					
Rust Yes <input type="checkbox"/> No <input checked="" type="checkbox"/>					
Sediment Yes <input type="checkbox"/> No <input checked="" type="checkbox"/>					
Microbes Yes <input type="checkbox"/> No <input checked="" type="checkbox"/>					
Left with Customer Yes <input type="checkbox"/> No <input checked="" type="checkbox"/>					
Appearance of fuel: <u>Clear Bright</u>					
<u>3/4</u> Capacity <u>2000</u> gallons					
Contaminates Found: Yes <input type="checkbox"/> No <input checked="" type="checkbox"/>					
Fuel Gauge Condition: OK <input checked="" type="checkbox"/> BAD <input type="checkbox"/>					
Float Condition: OK <input checked="" type="checkbox"/> BAD <input type="checkbox"/>					
Fuel Lines Condition: OK <input checked="" type="checkbox"/> BAD <input type="checkbox"/>					
Appearance: <u>GOOD</u>					
Technician Recommendations: <u>Recommend AA in 2019. Fuel tank very clean.</u>

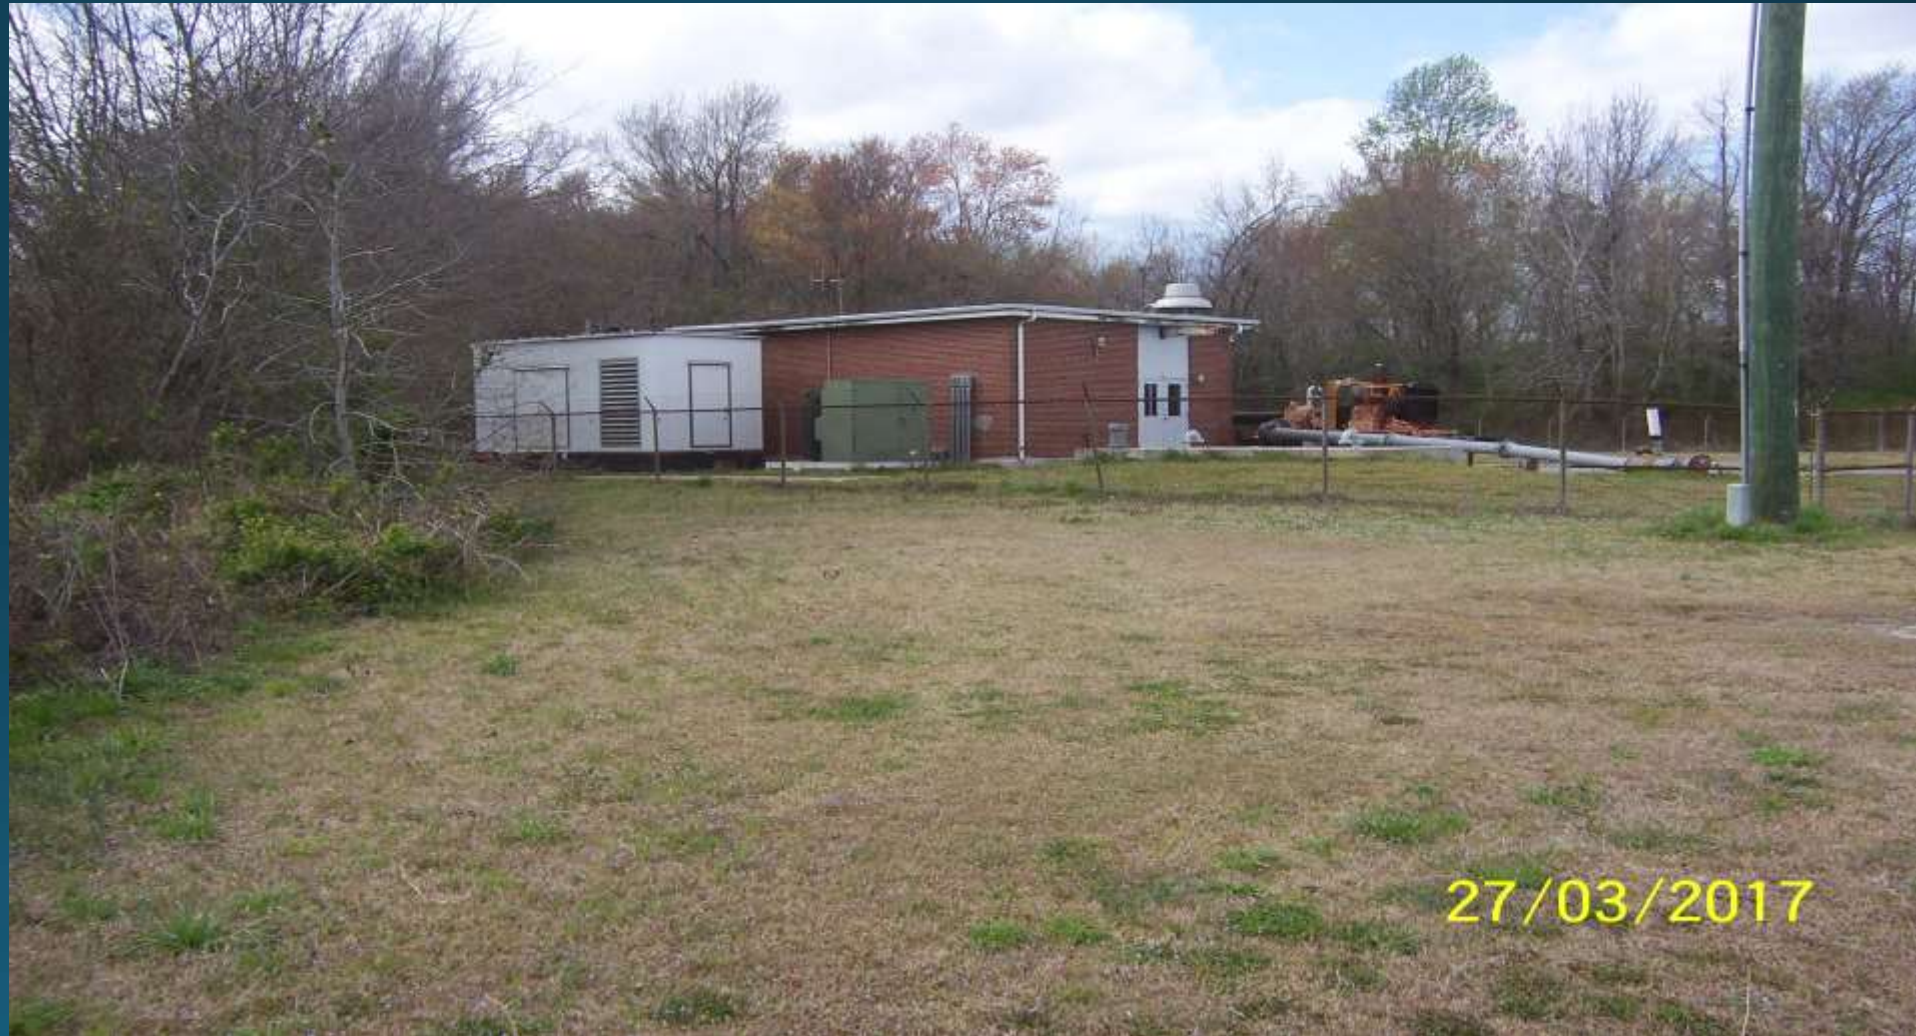
750 Kw Caterpillar Generator
1300 gallon fuel cell
42.5 hrs.

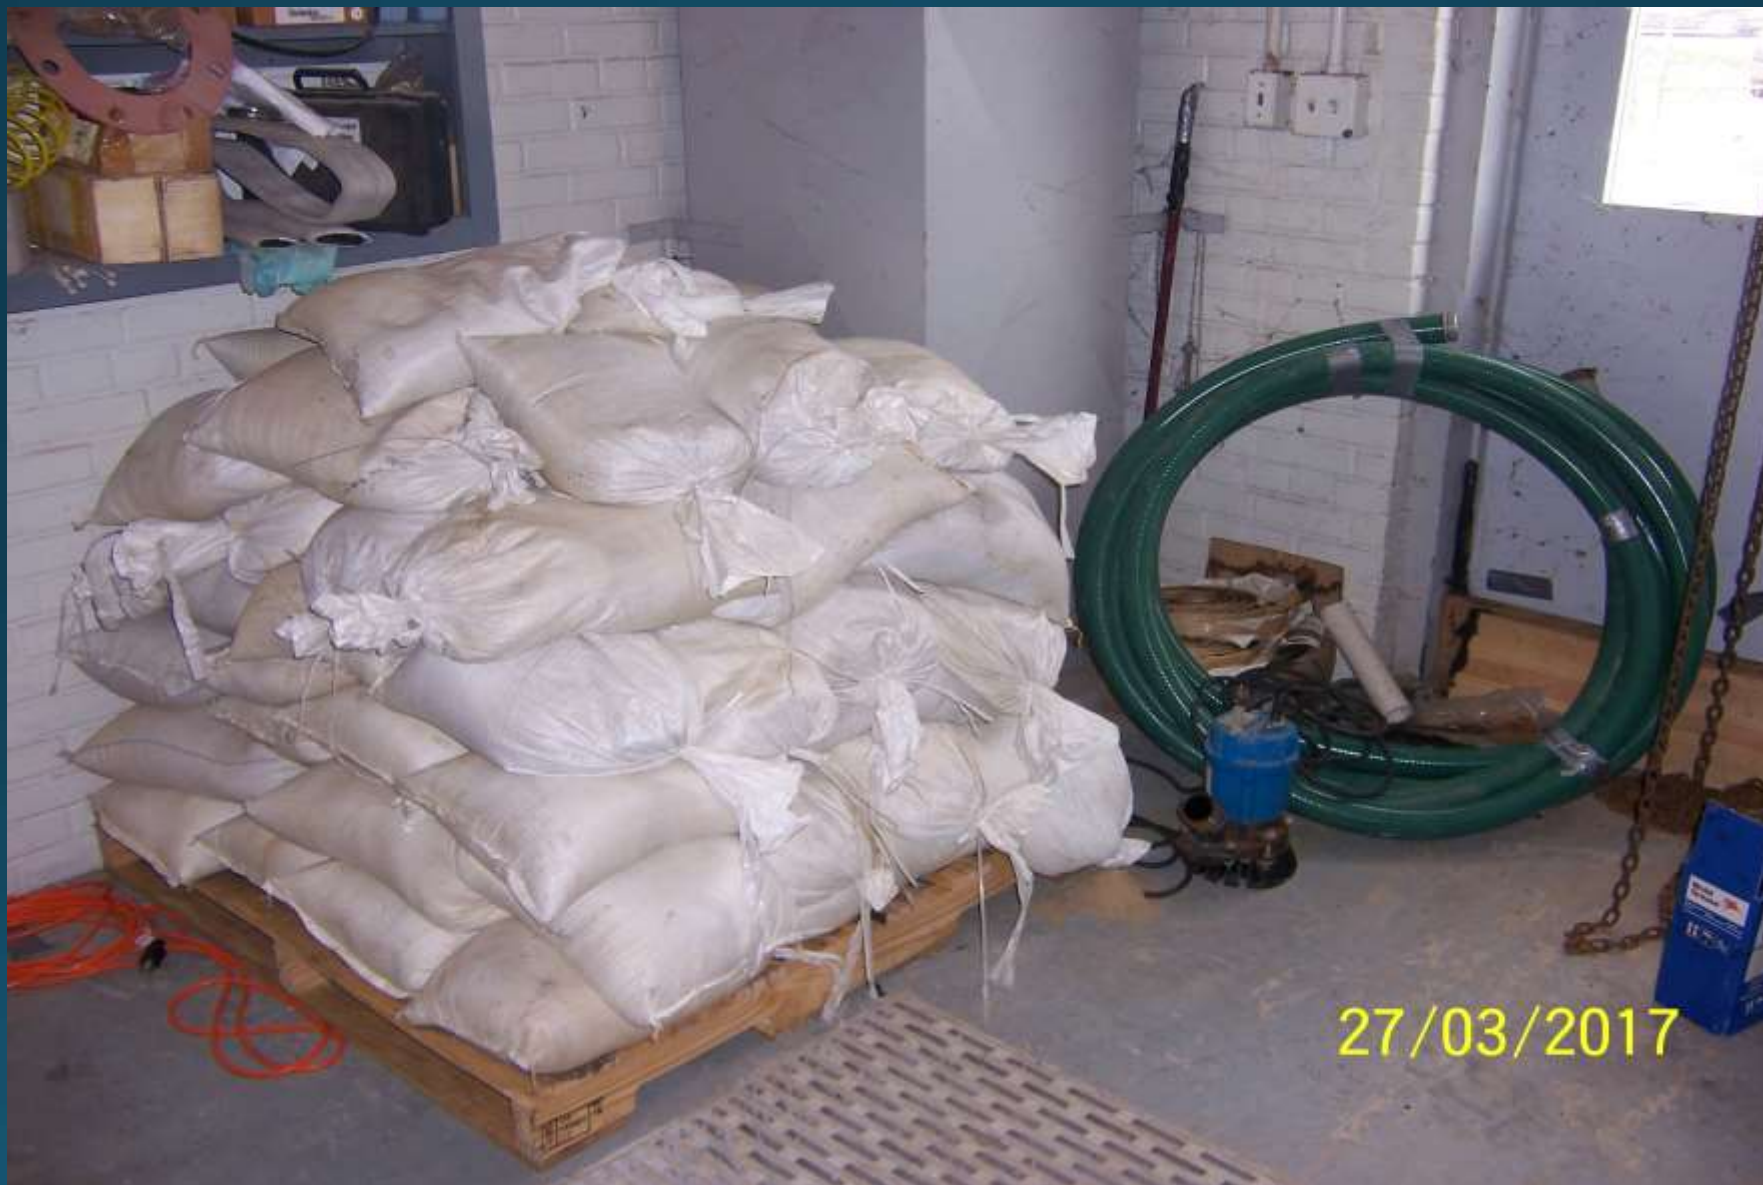
Sandbags, sump pump and discharge hose

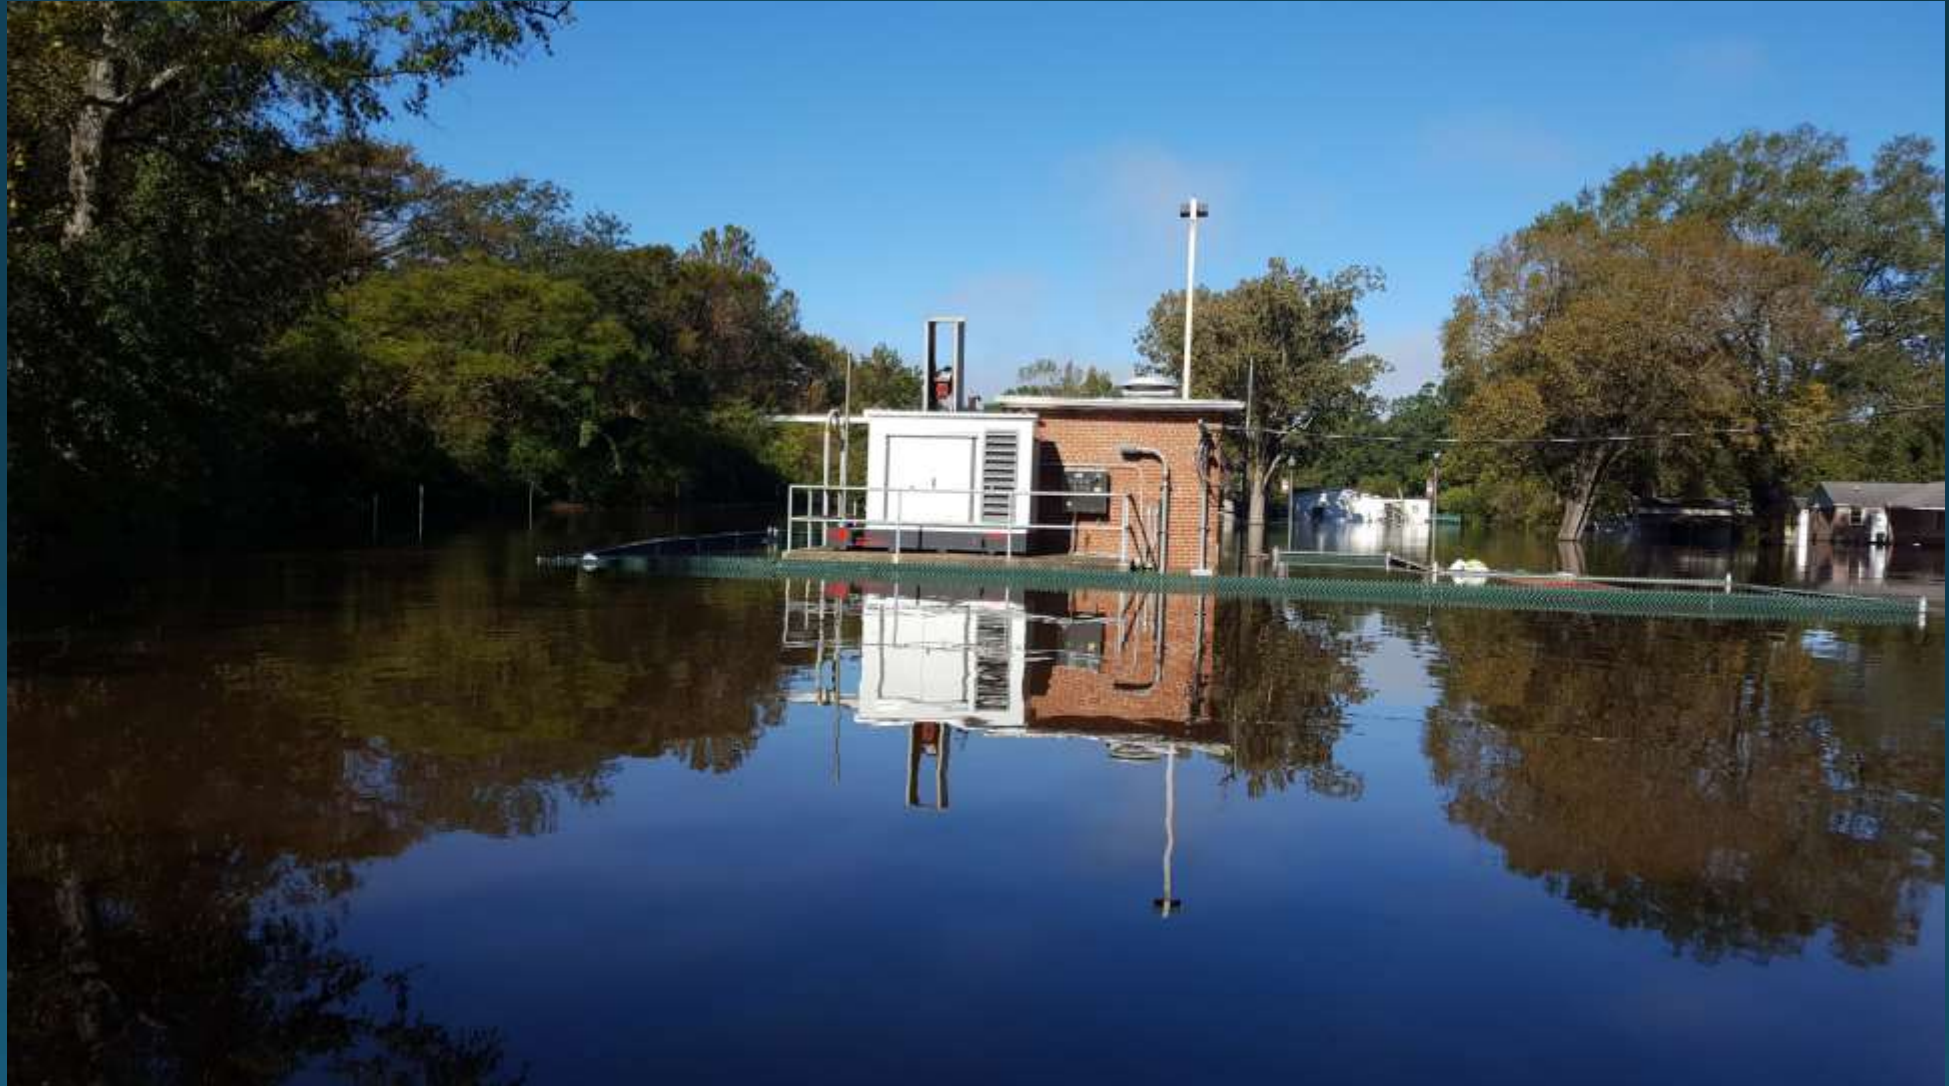
100 Kw Caterpillar Generator
200 gallon fuel cell
249.6 hrs.

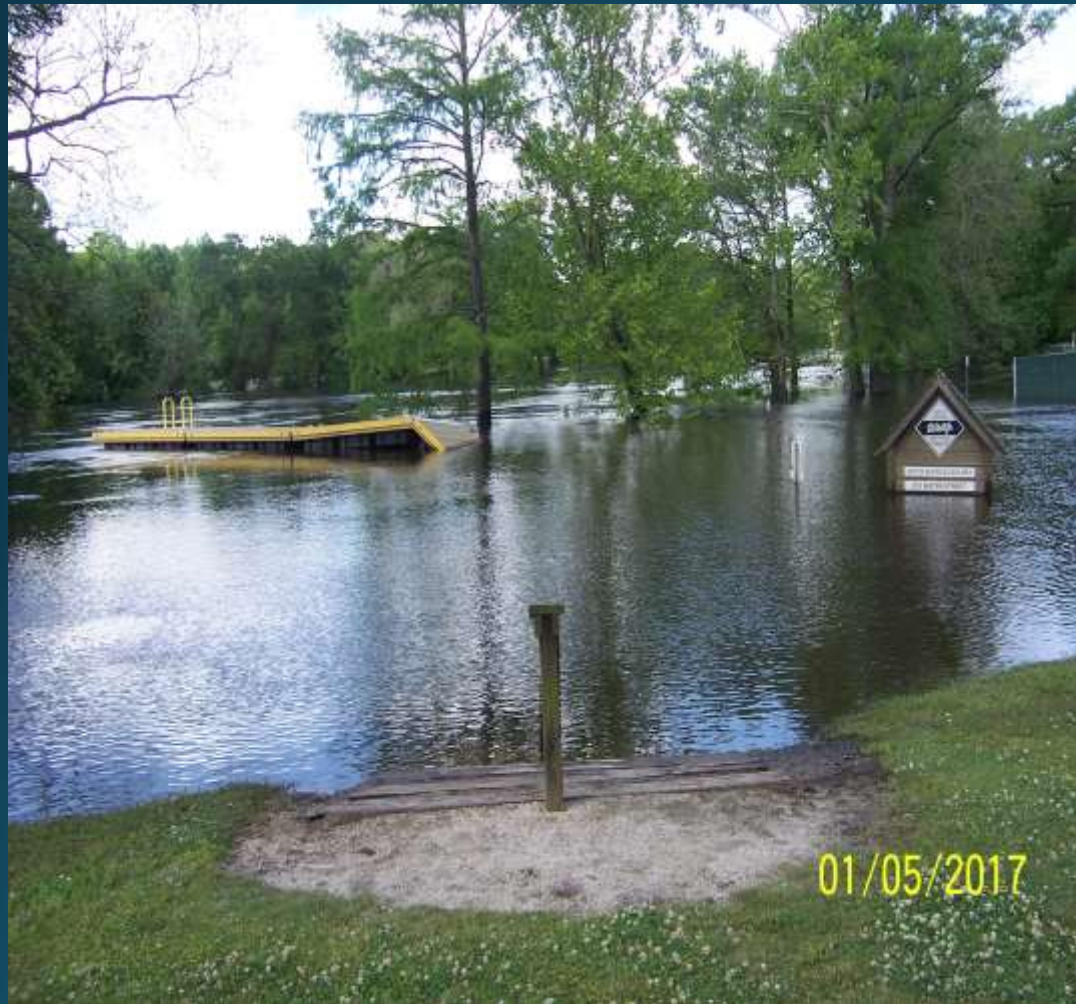
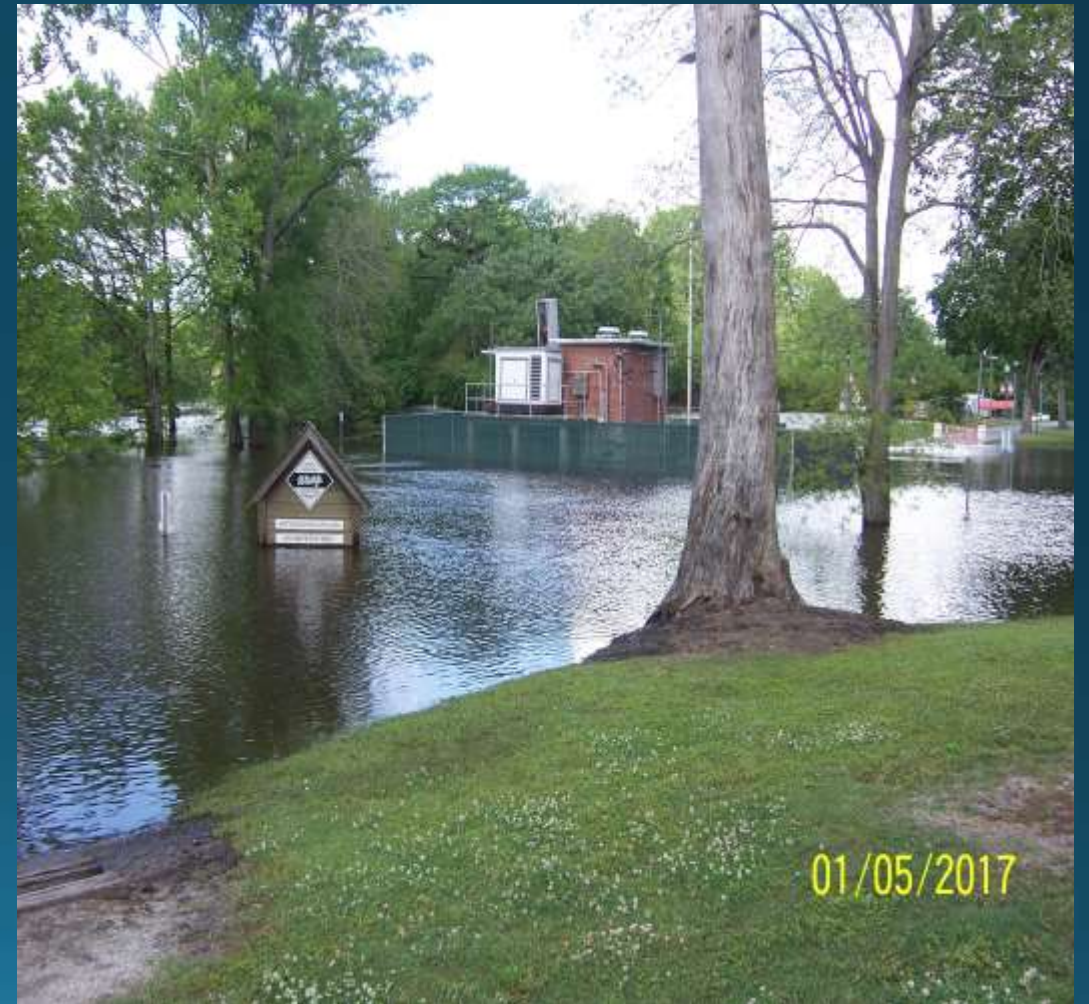
Grifton PS on May 1, 2017
Rising Water from Rain on April 25, 2017

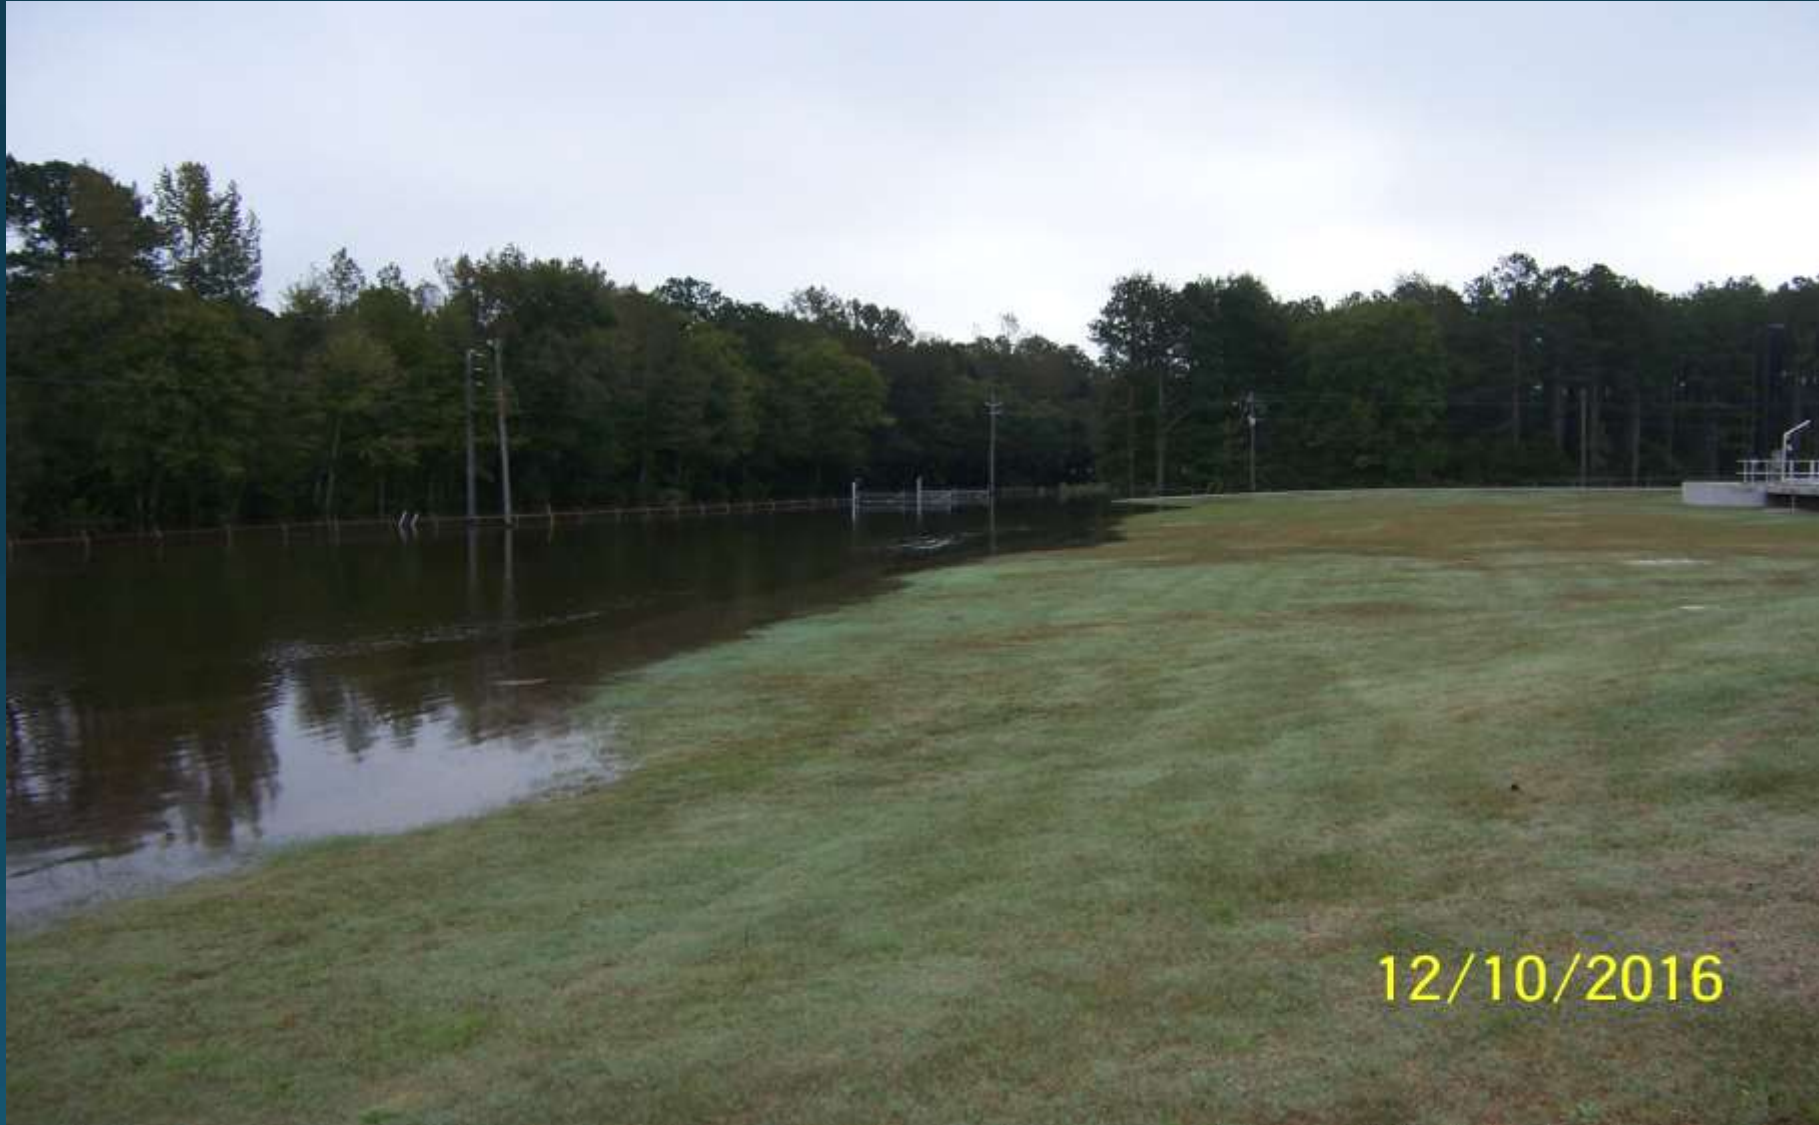
3 days before crest

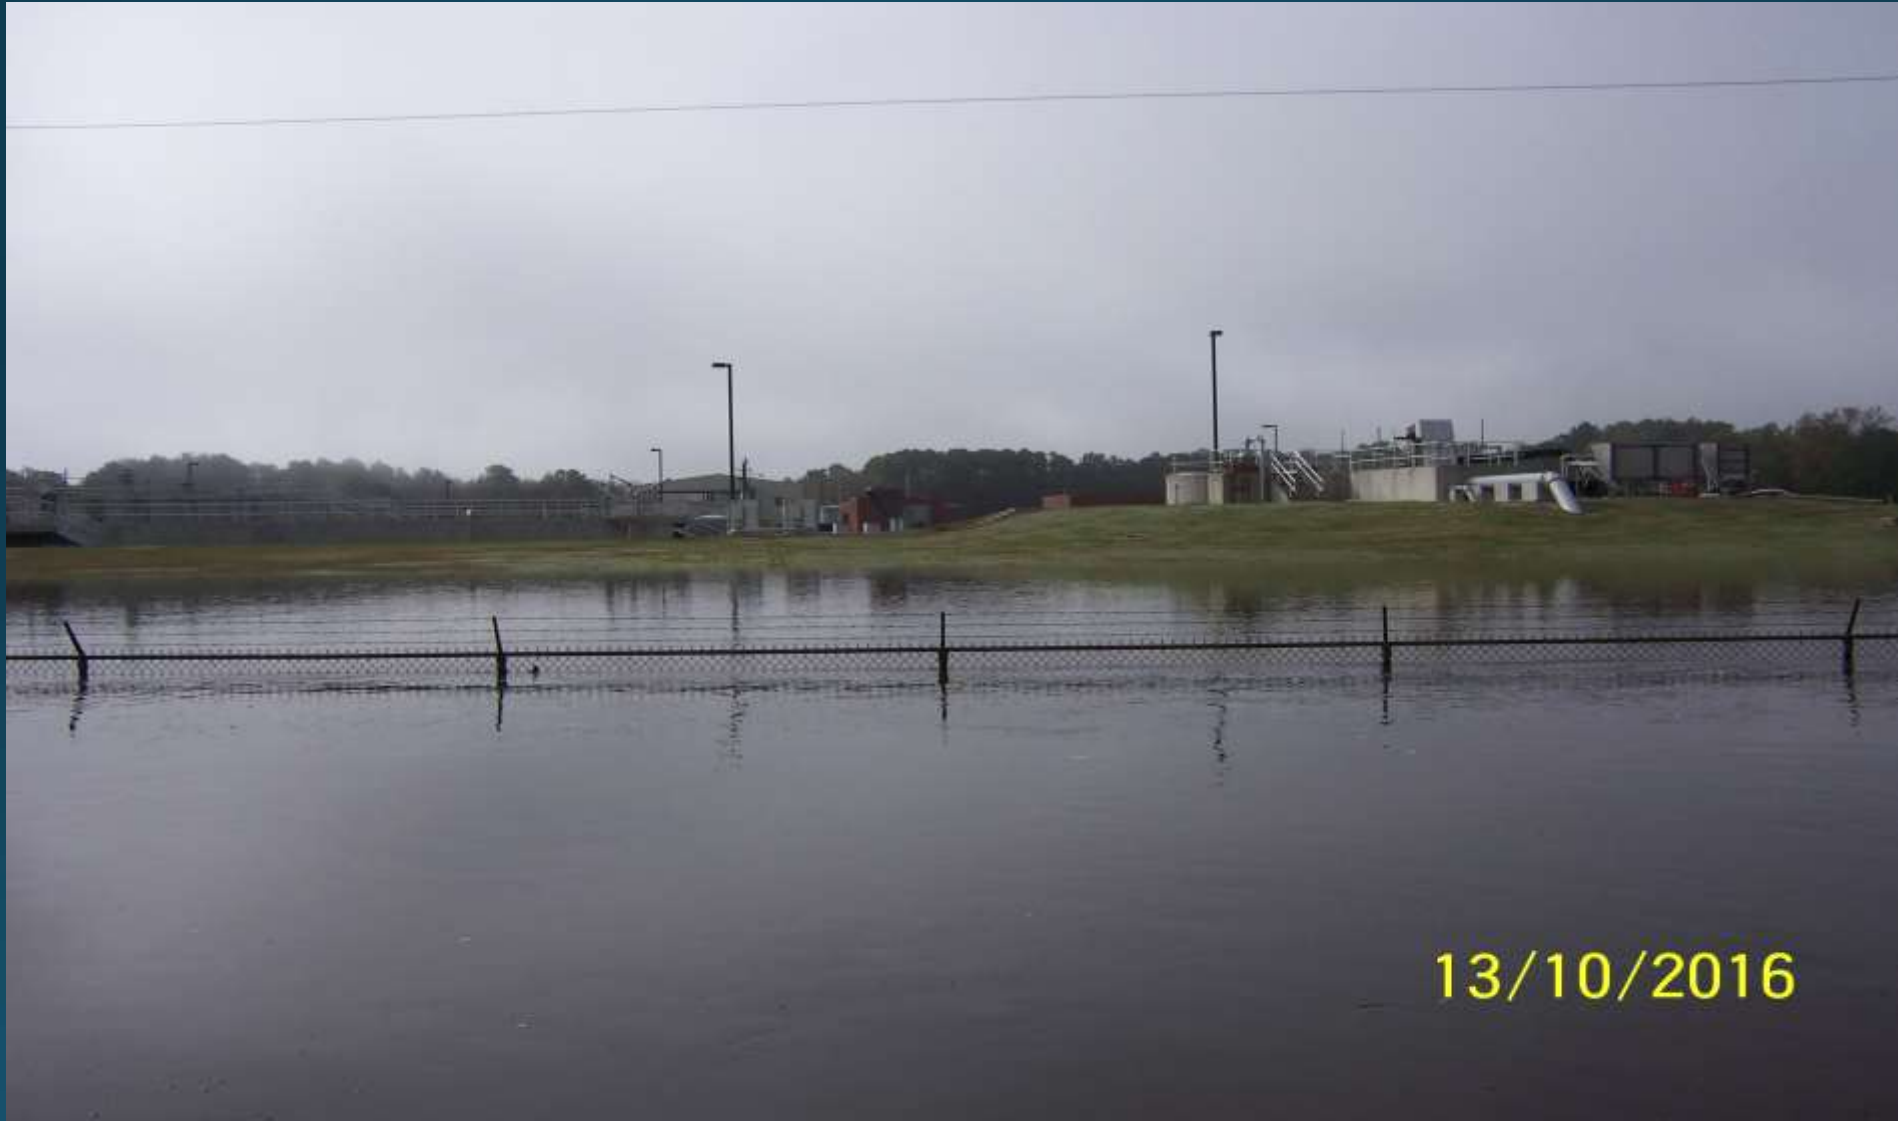
2 days before crest

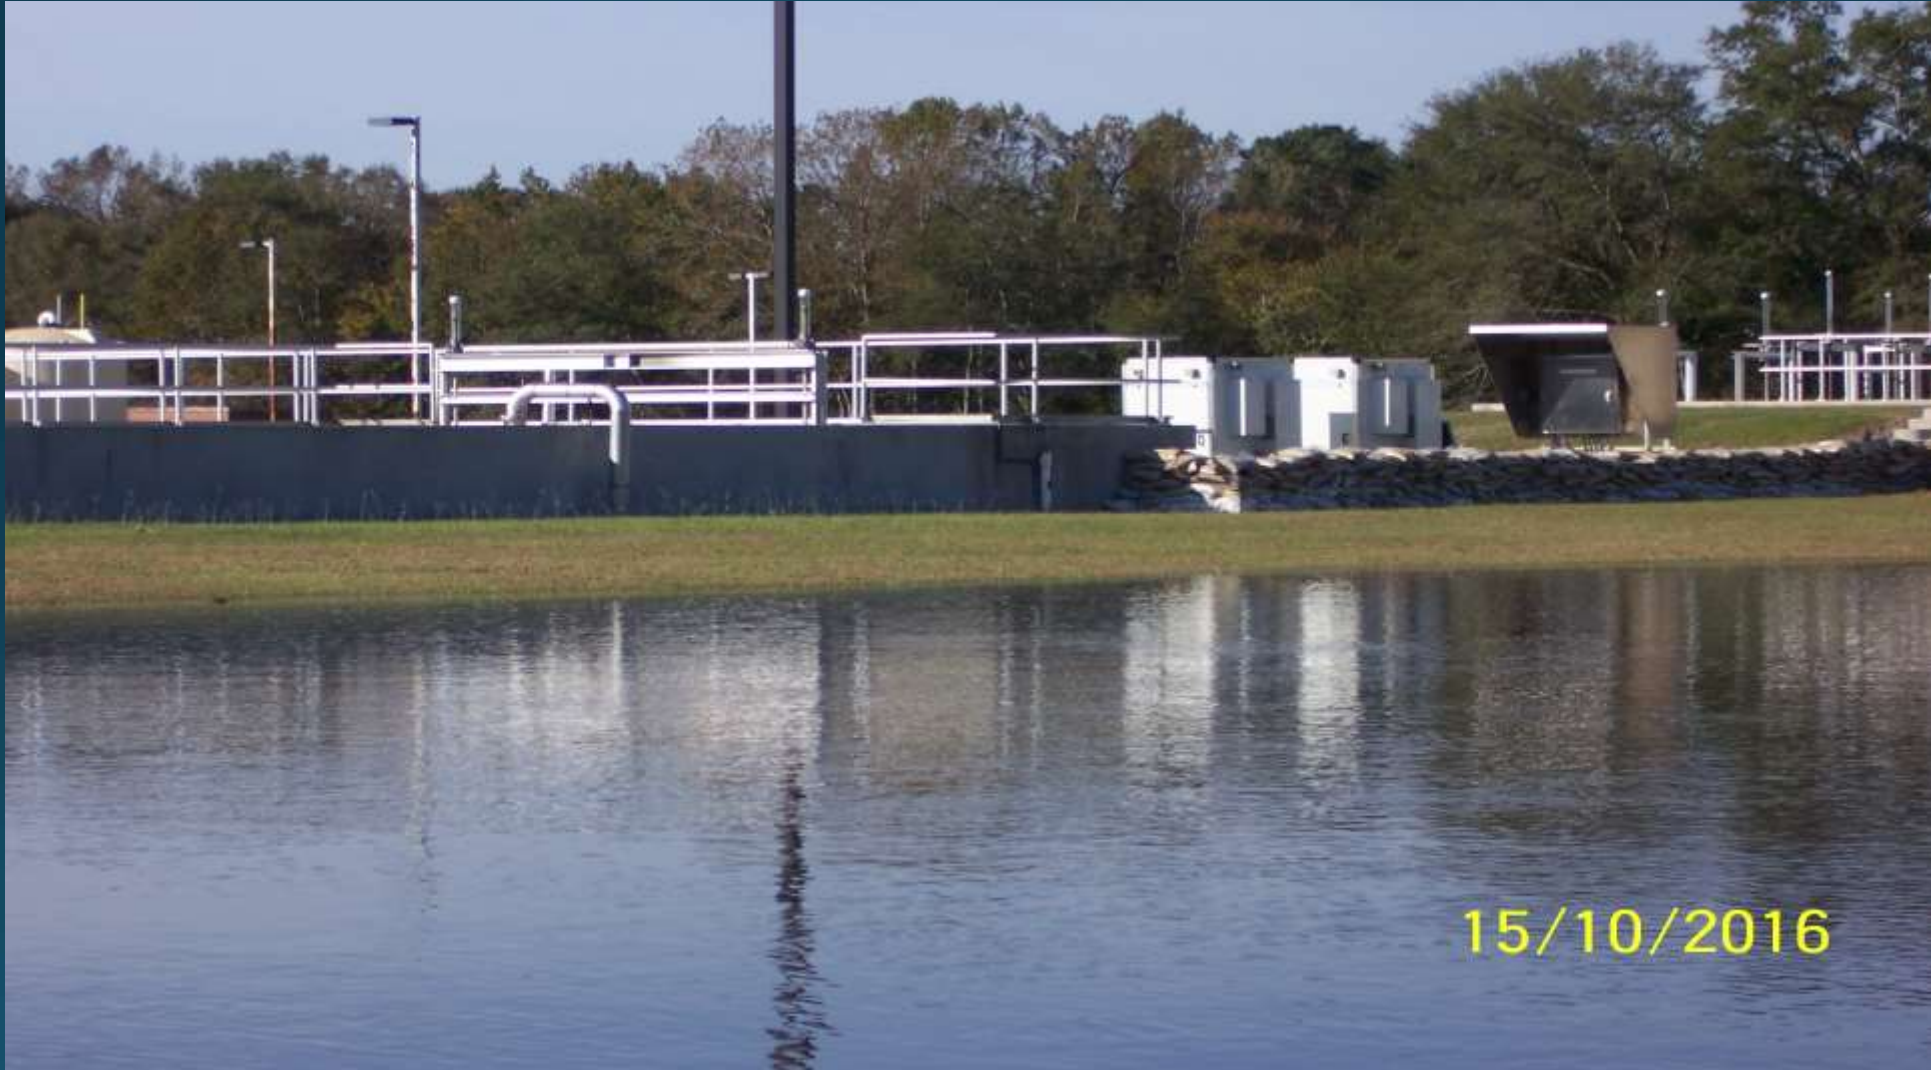
River has crested

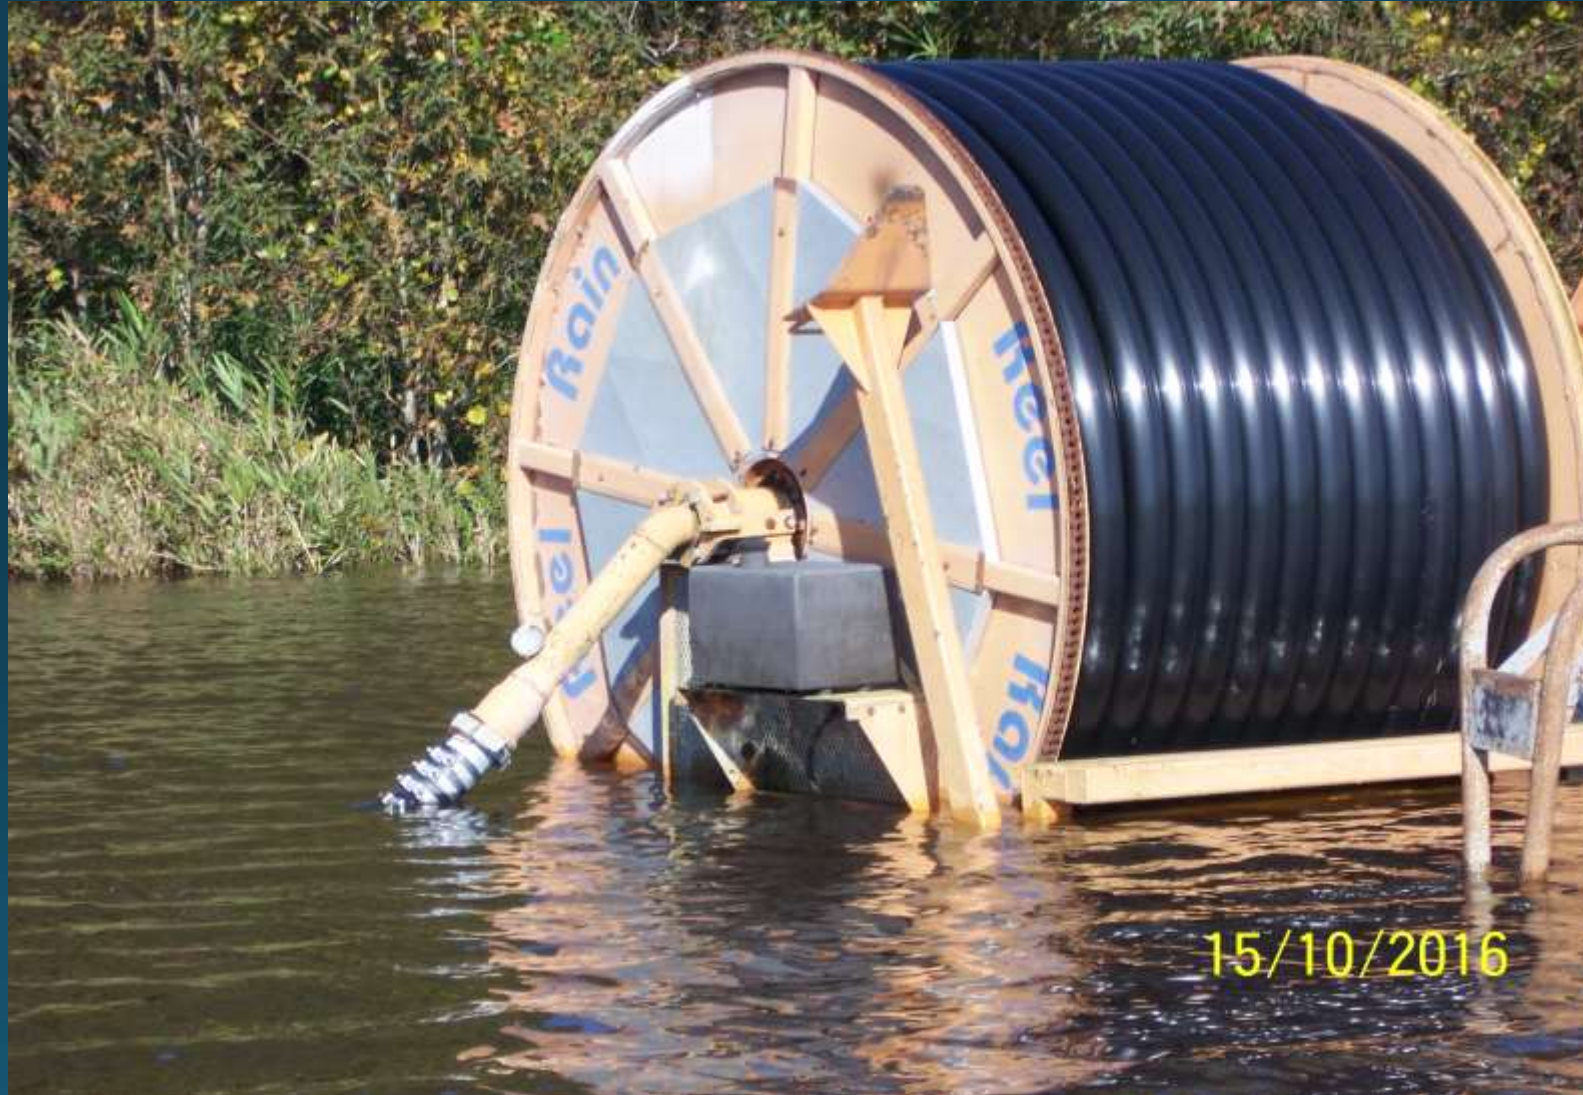
2nd Flood

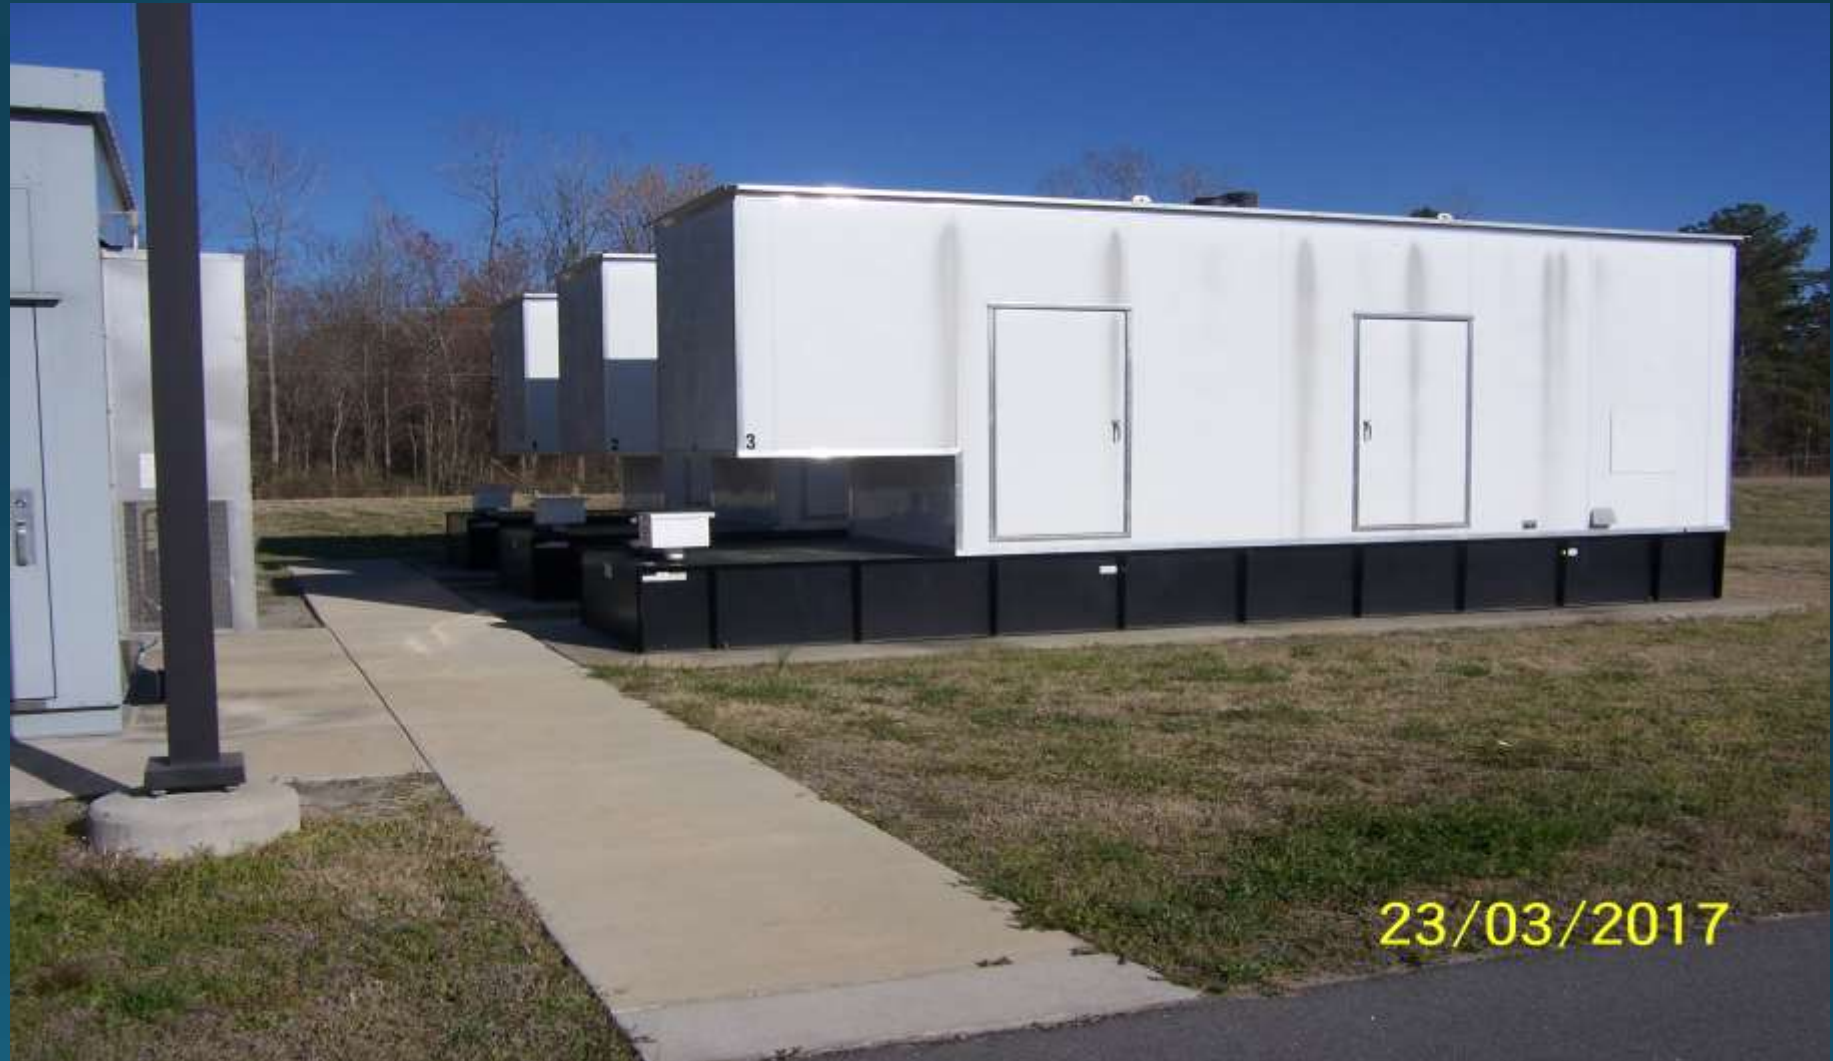
Three (3) 600 Kw Caterpillar Generators
2,000 gallon fuel cells for each generator
#1-86.6 hrs.
#2-54.3 hrs.
#3-0 hrs.
