Contentnea Metropolitan Sewerage District

Hurricane Matthew
October 8, 2016

Chuck Smithwick
District Manager, CMSD

A Look Back
at Hurricane
Matthew

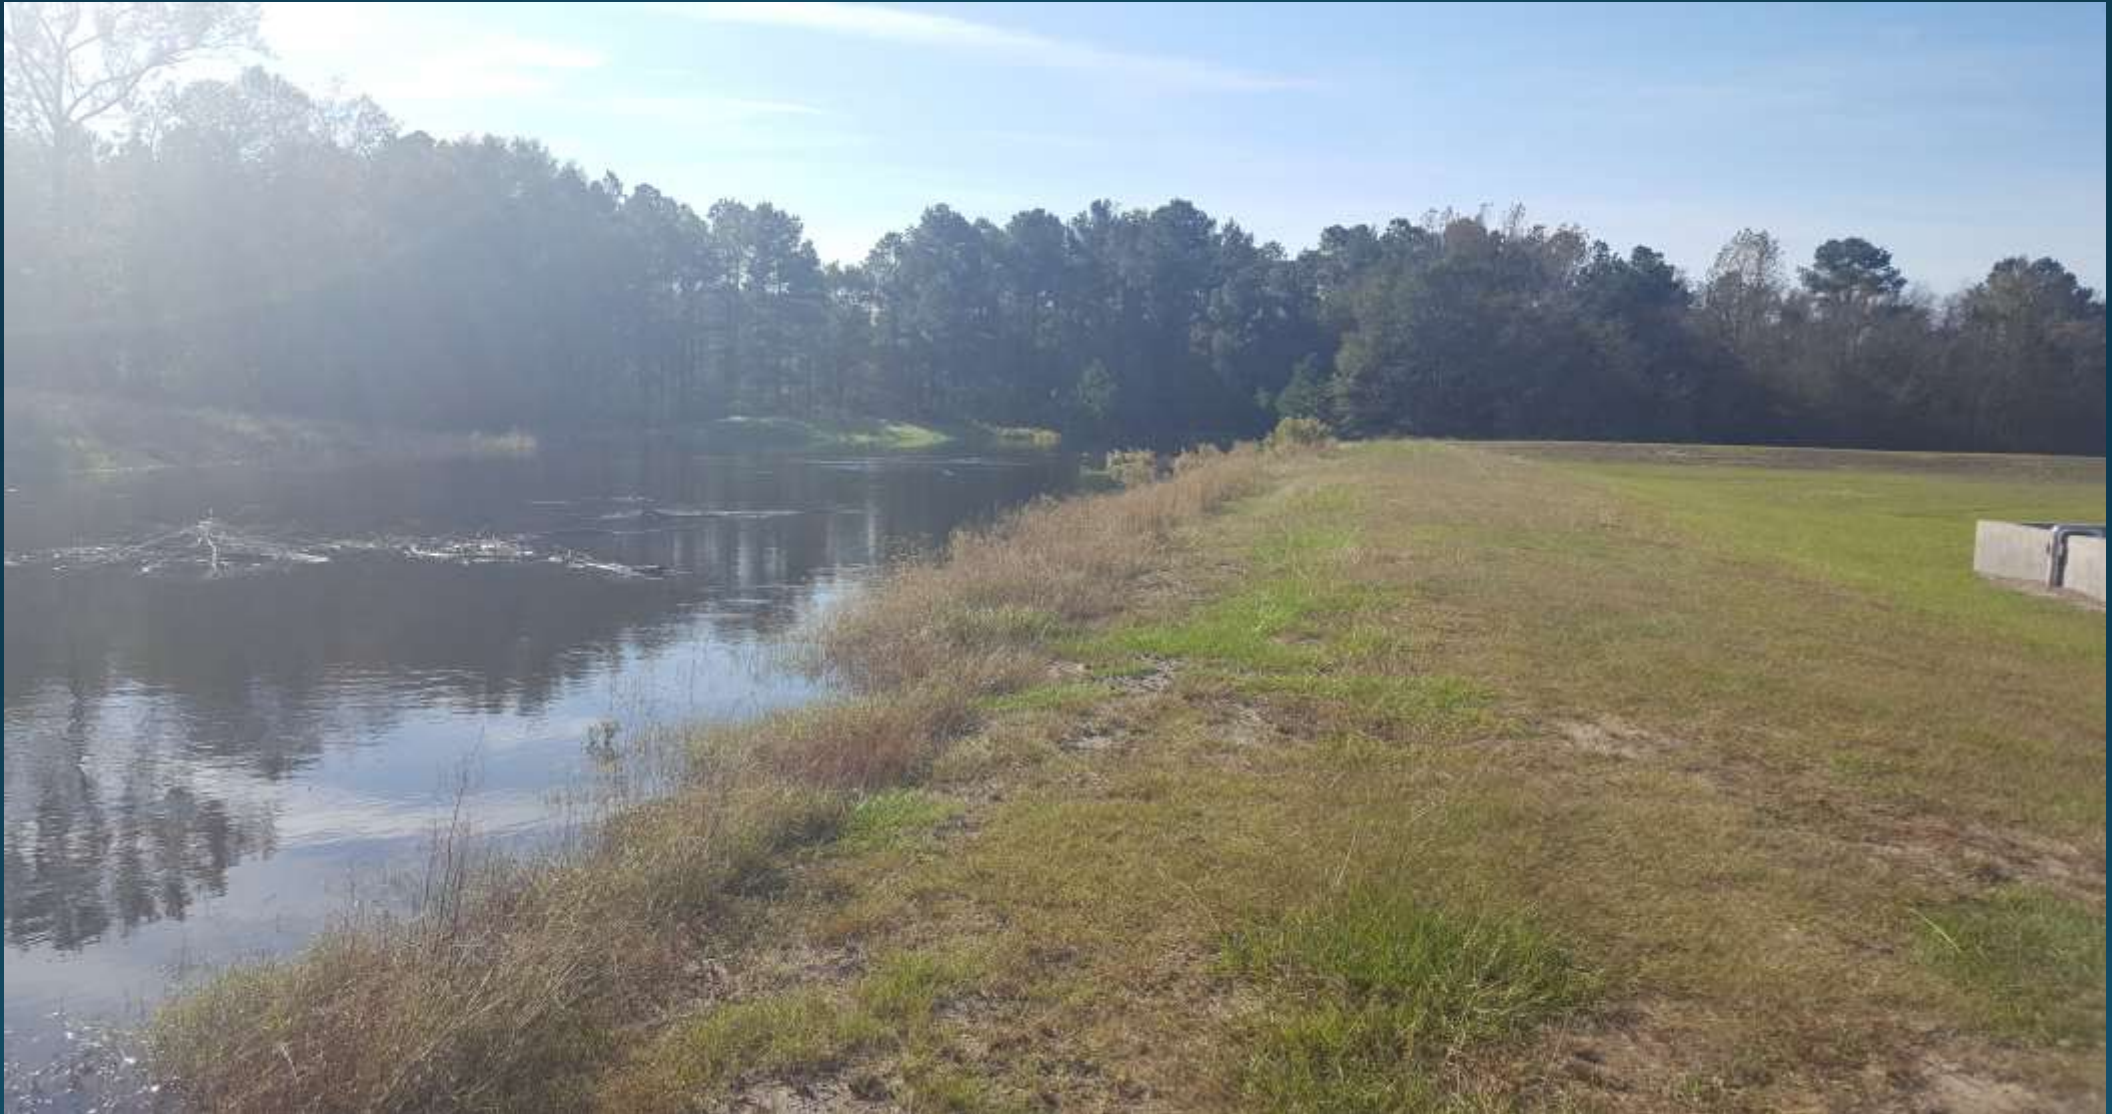
Rising water on Flood Dike

- Waiting for the State's determination and what funds (if any) may be available
- Engineers estimate \$1.5 million to "hardened" flood dike around WWTP, Hwy 11 and Grifton Pump station
- North Carolina Division of Water Infrastructure (NCDWI) contacted our engineers after the flood and requested a list of potential mitigation projects
- Most recent Capital Improvement Plan (CIP) was completed in April 2017 and has listed this as the #1 Priority
