# Central Johnston County Regional Wastewater Treatment Plant

## Recovery from Hurricane Matthew Flooding

### July 2017

### Johnston County Department of Utilities

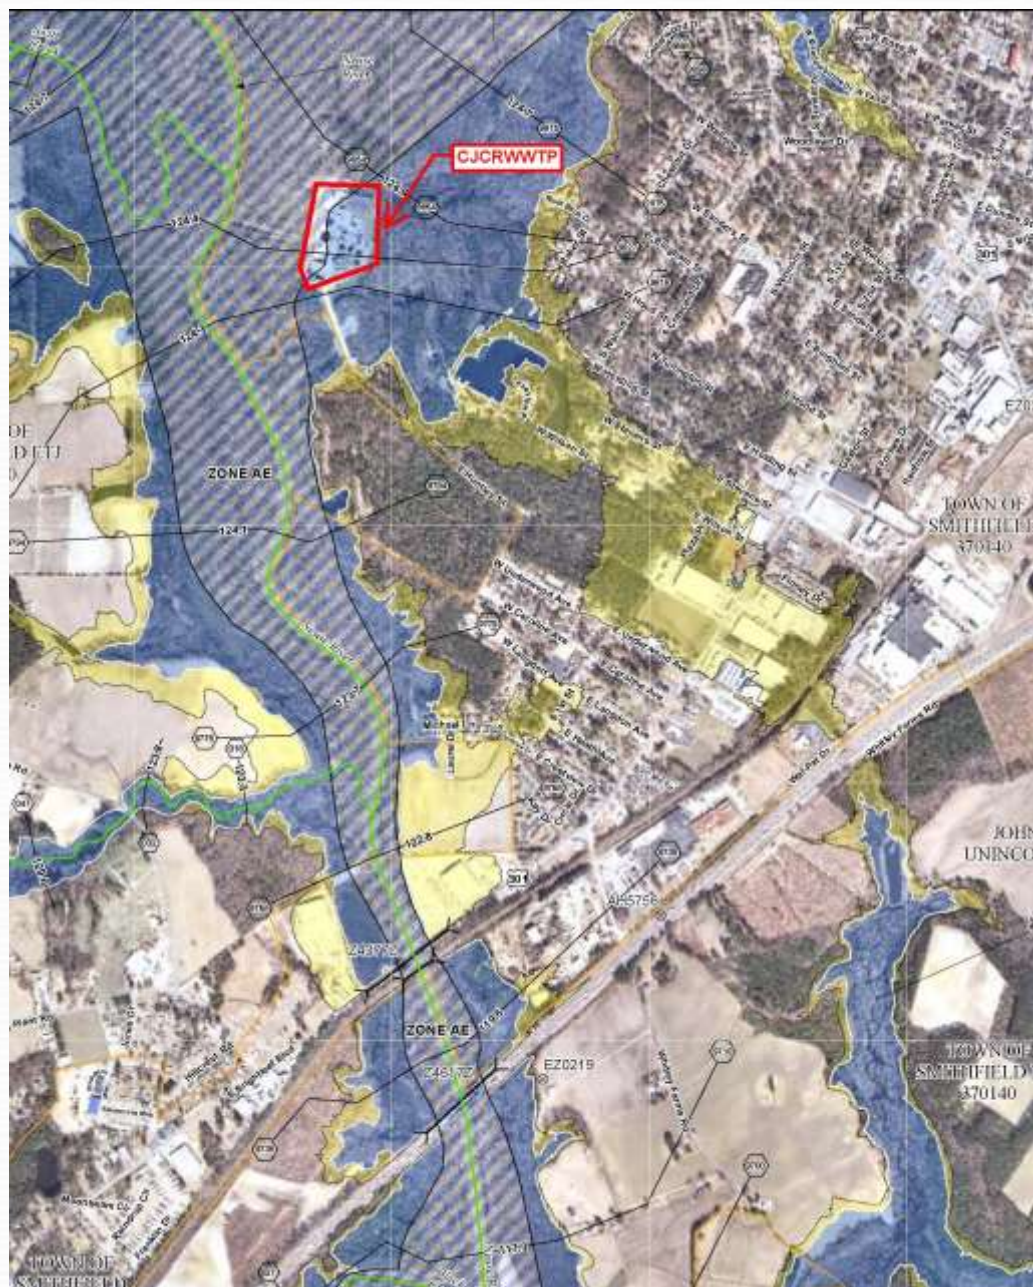
## FEMA NFIP Map

100 yr. flood stage -	El. 124.6
Top of dike -	El. 127.5
500 yr. flood stage -	El. 130.0

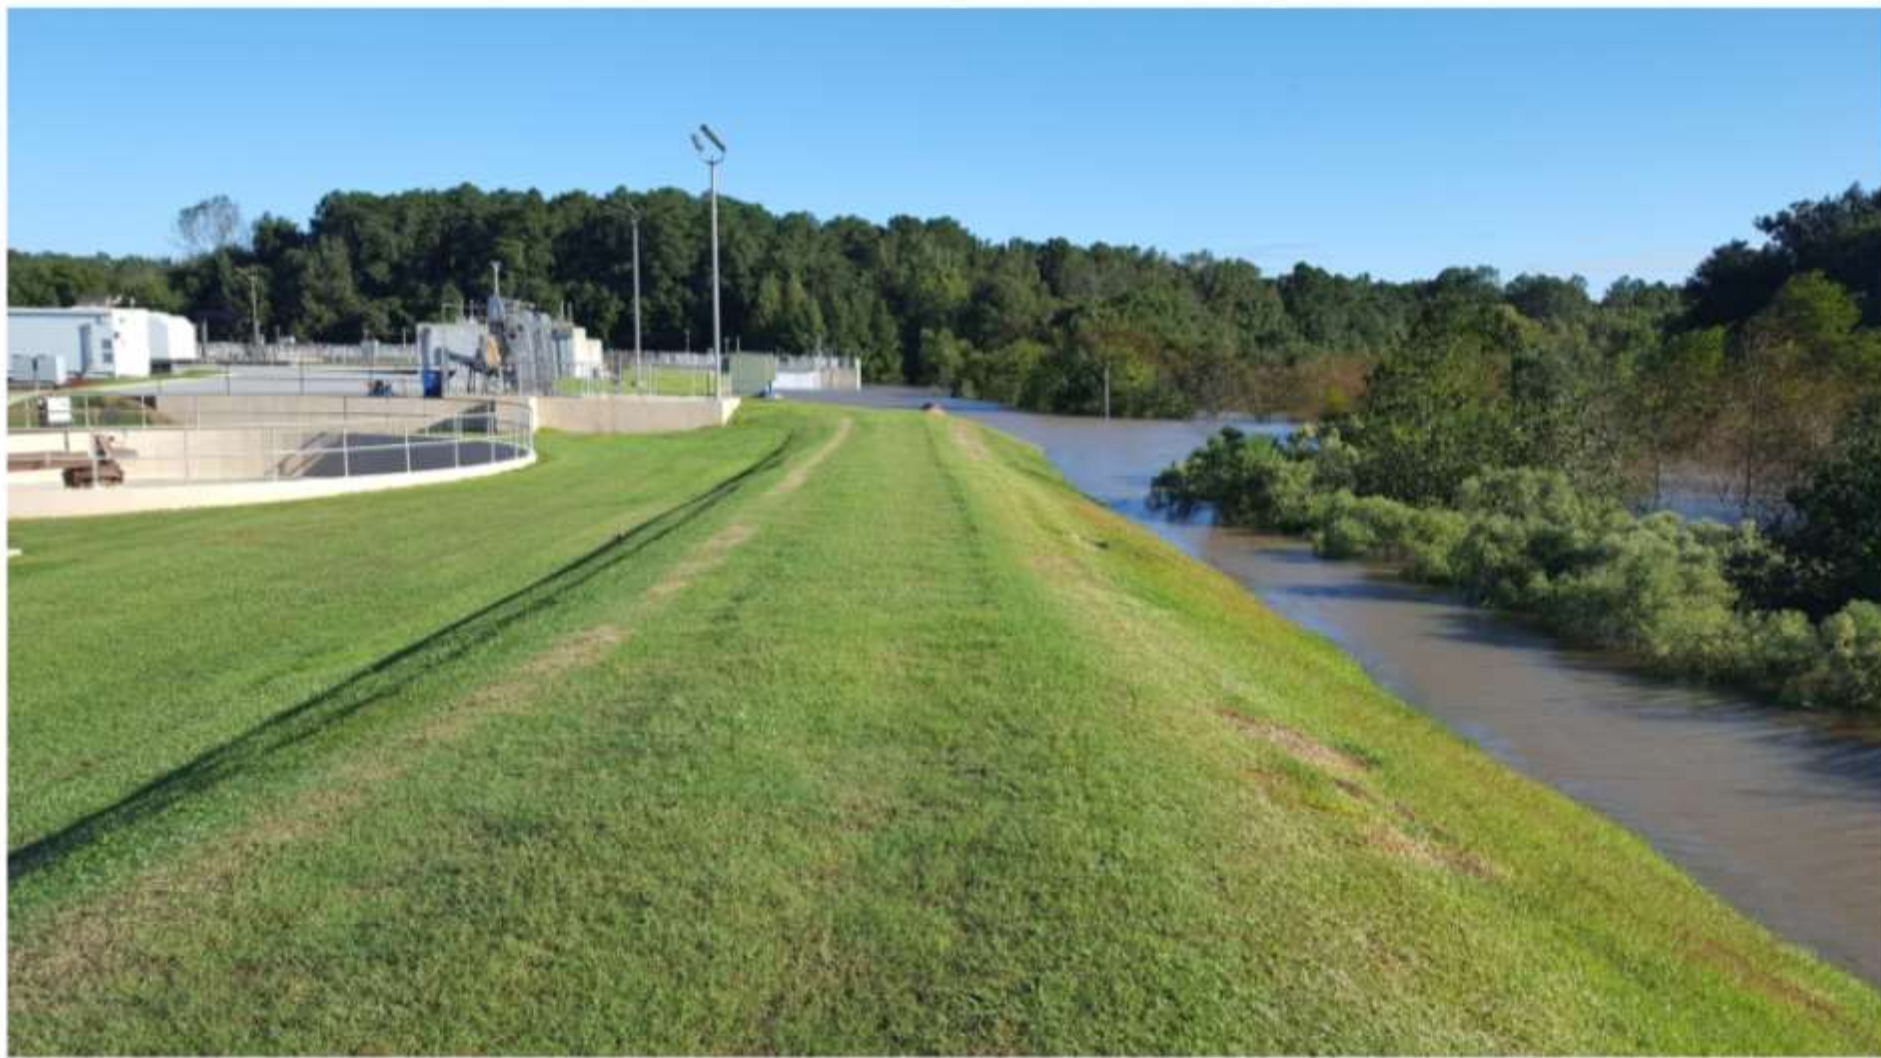
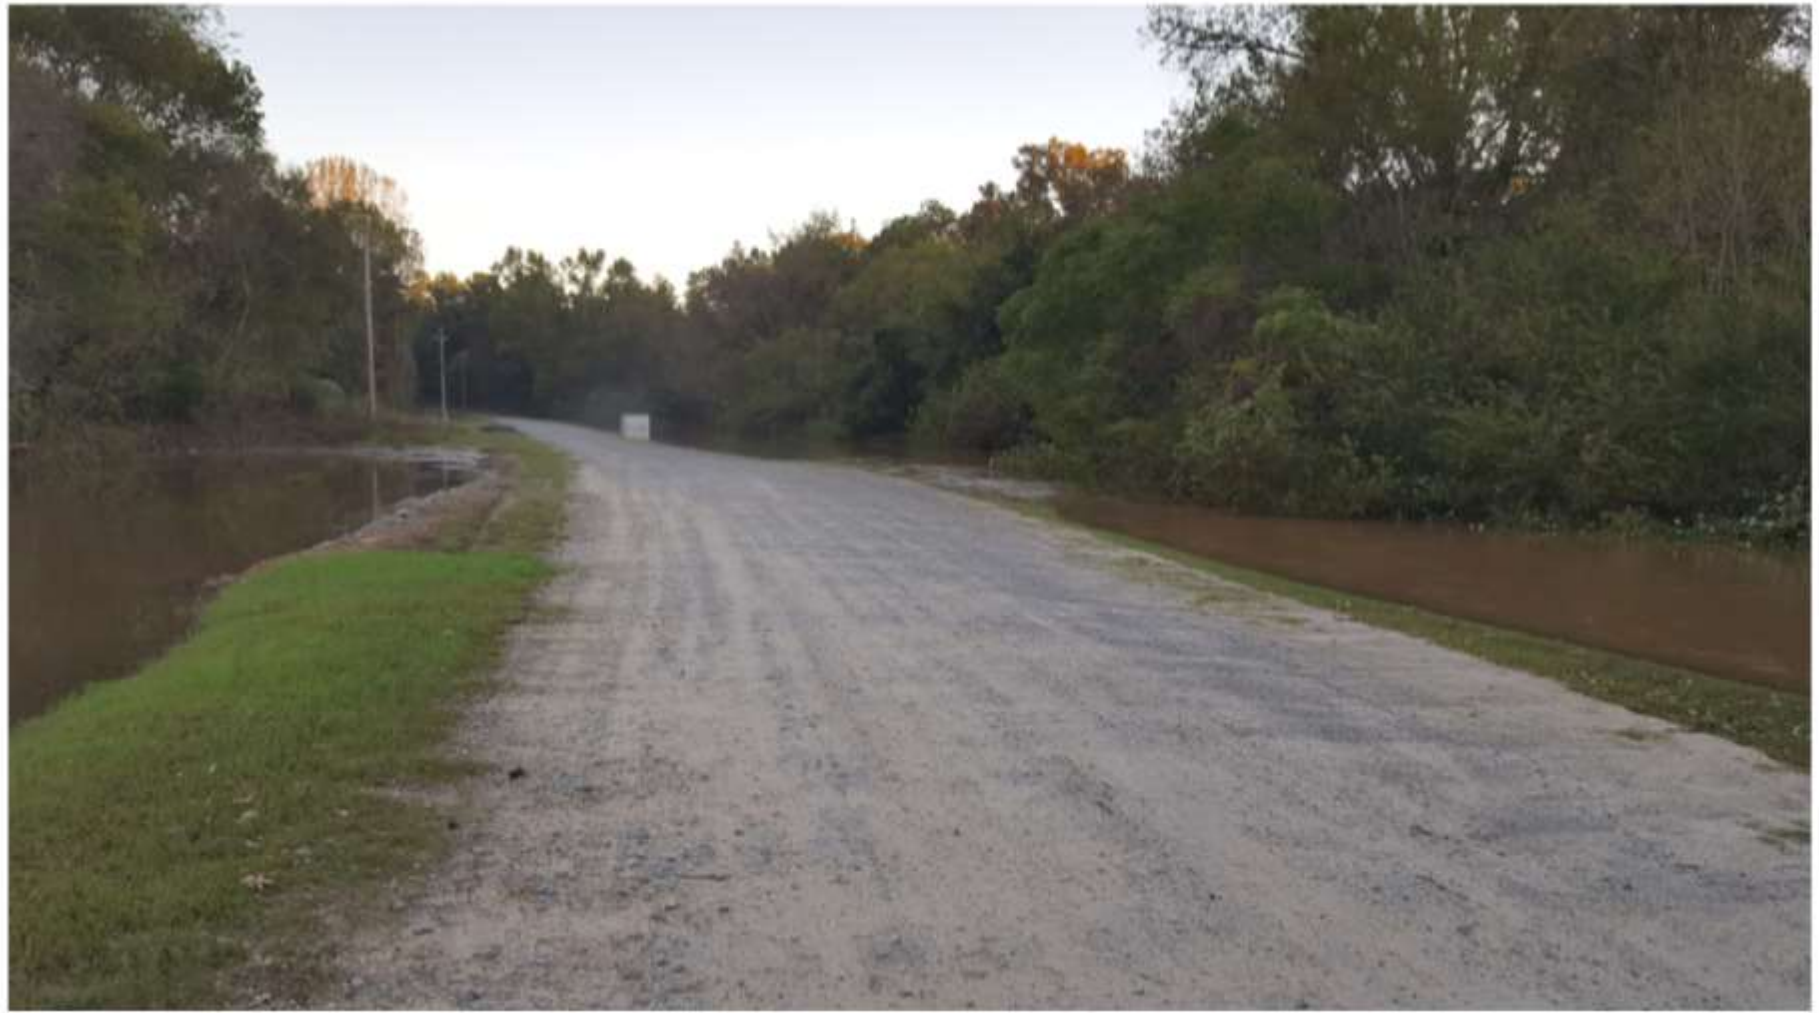
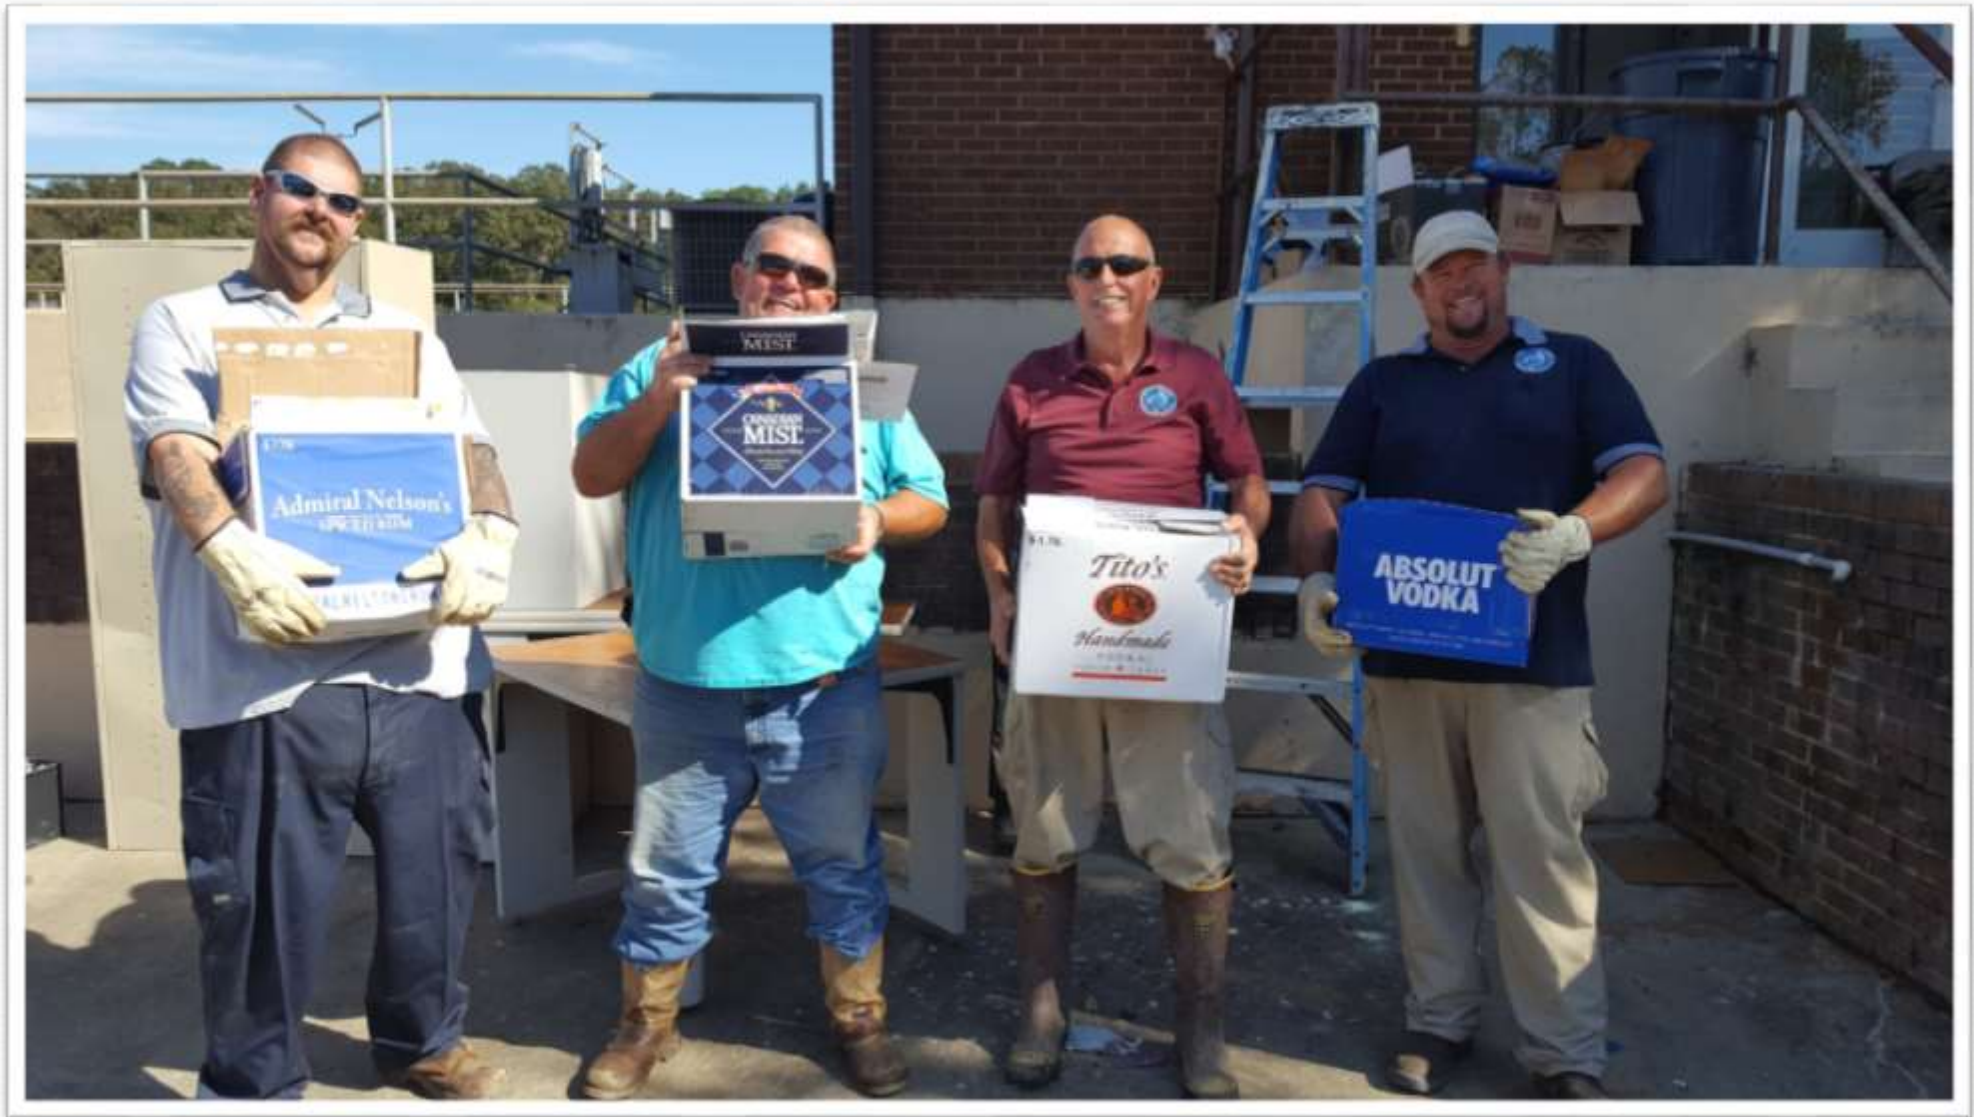
## October 10, 2017 – 2:30 AM – River level reaches 128.5 ft. at County wwtp site

- 10:00 AM - As river level rises, plant staff are mustered to move equipment and supplies to high(er) ground
- 10:00 PM - WW Treatment Manager and WWTP Superintendent disconnect all power to all process equipment and instruct Smithfield Power to disconnect supply to plant
- 10:30 PM - River overtops flood protection dike and plant entrance road. **The plant is abandoned.**
