# Central Johnston County Regional Wastewater Treatment Plant

## Recovery from Hurricane Matthew Flooding

### July 2017

### Johnston County Department of Utilities

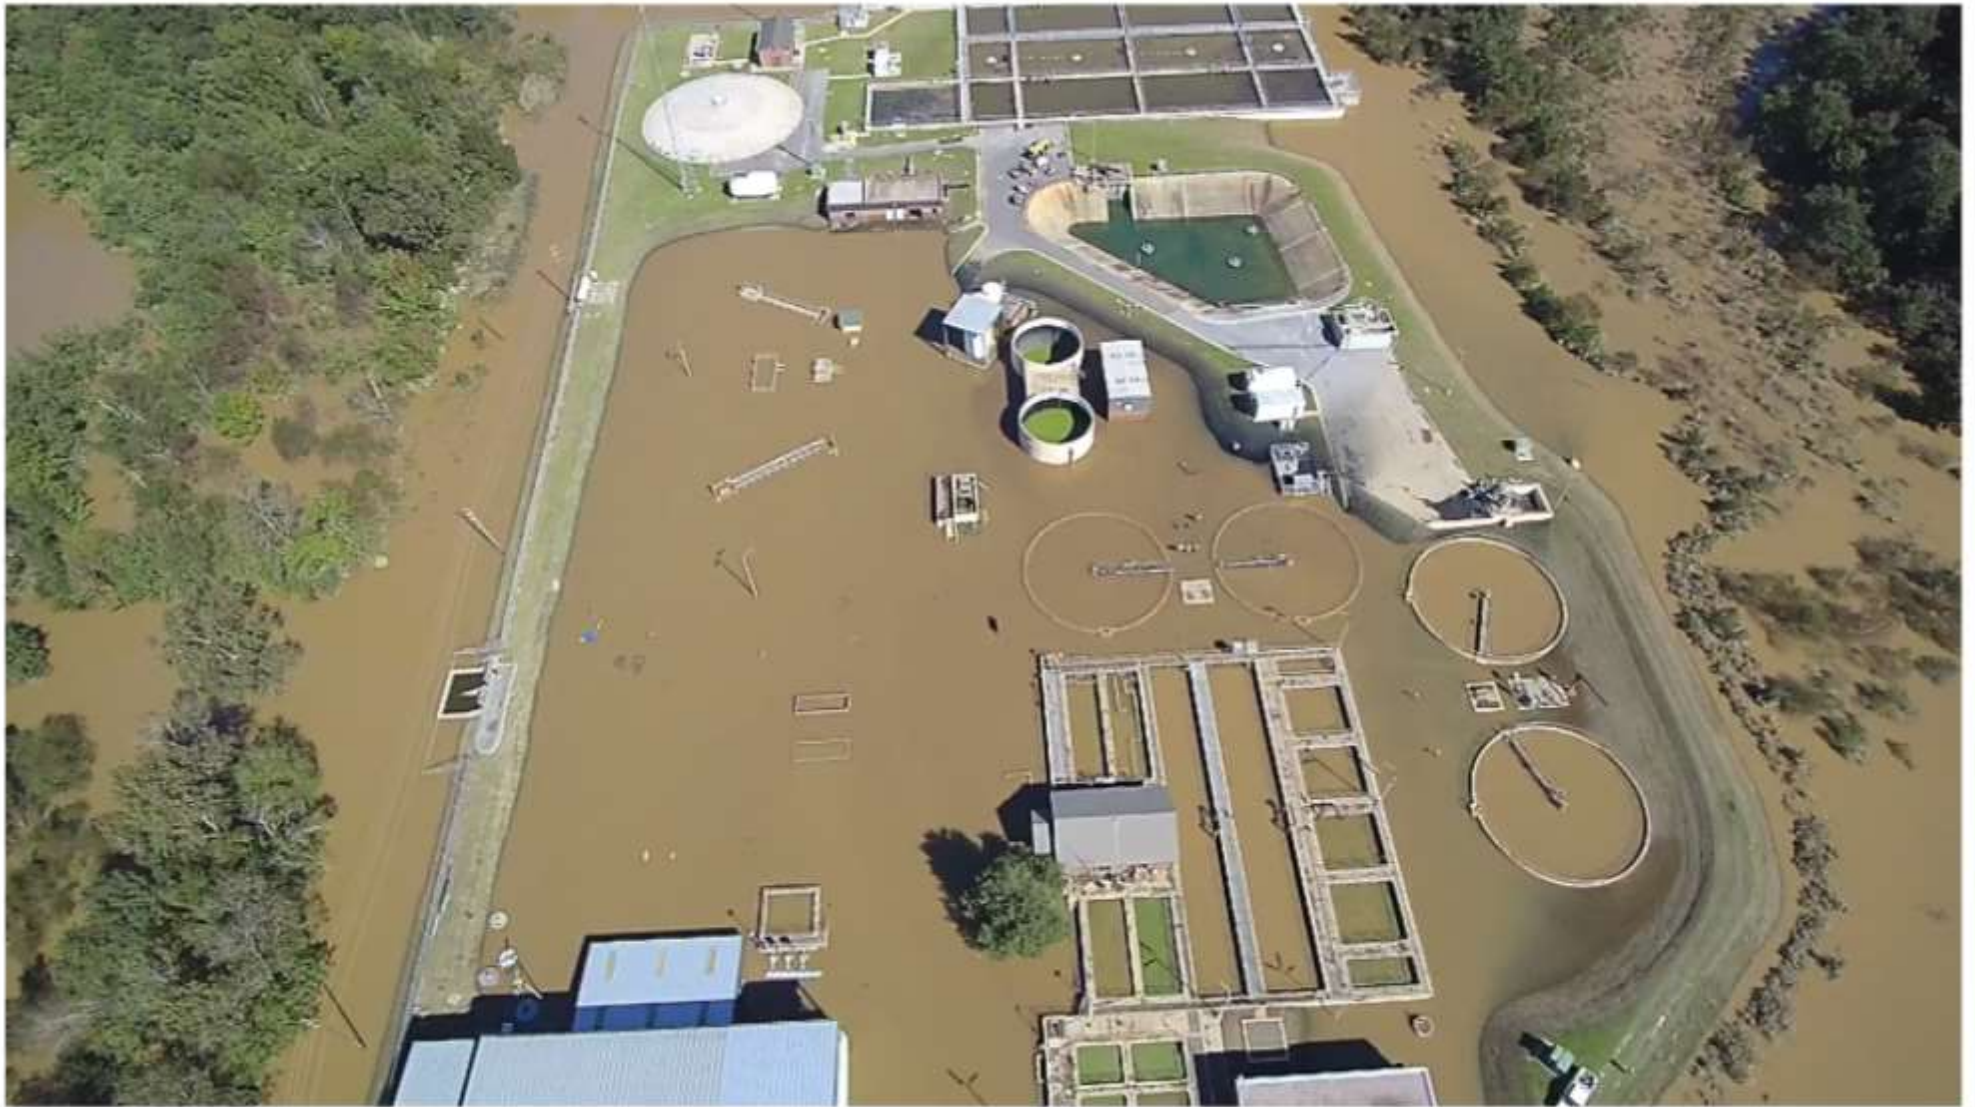
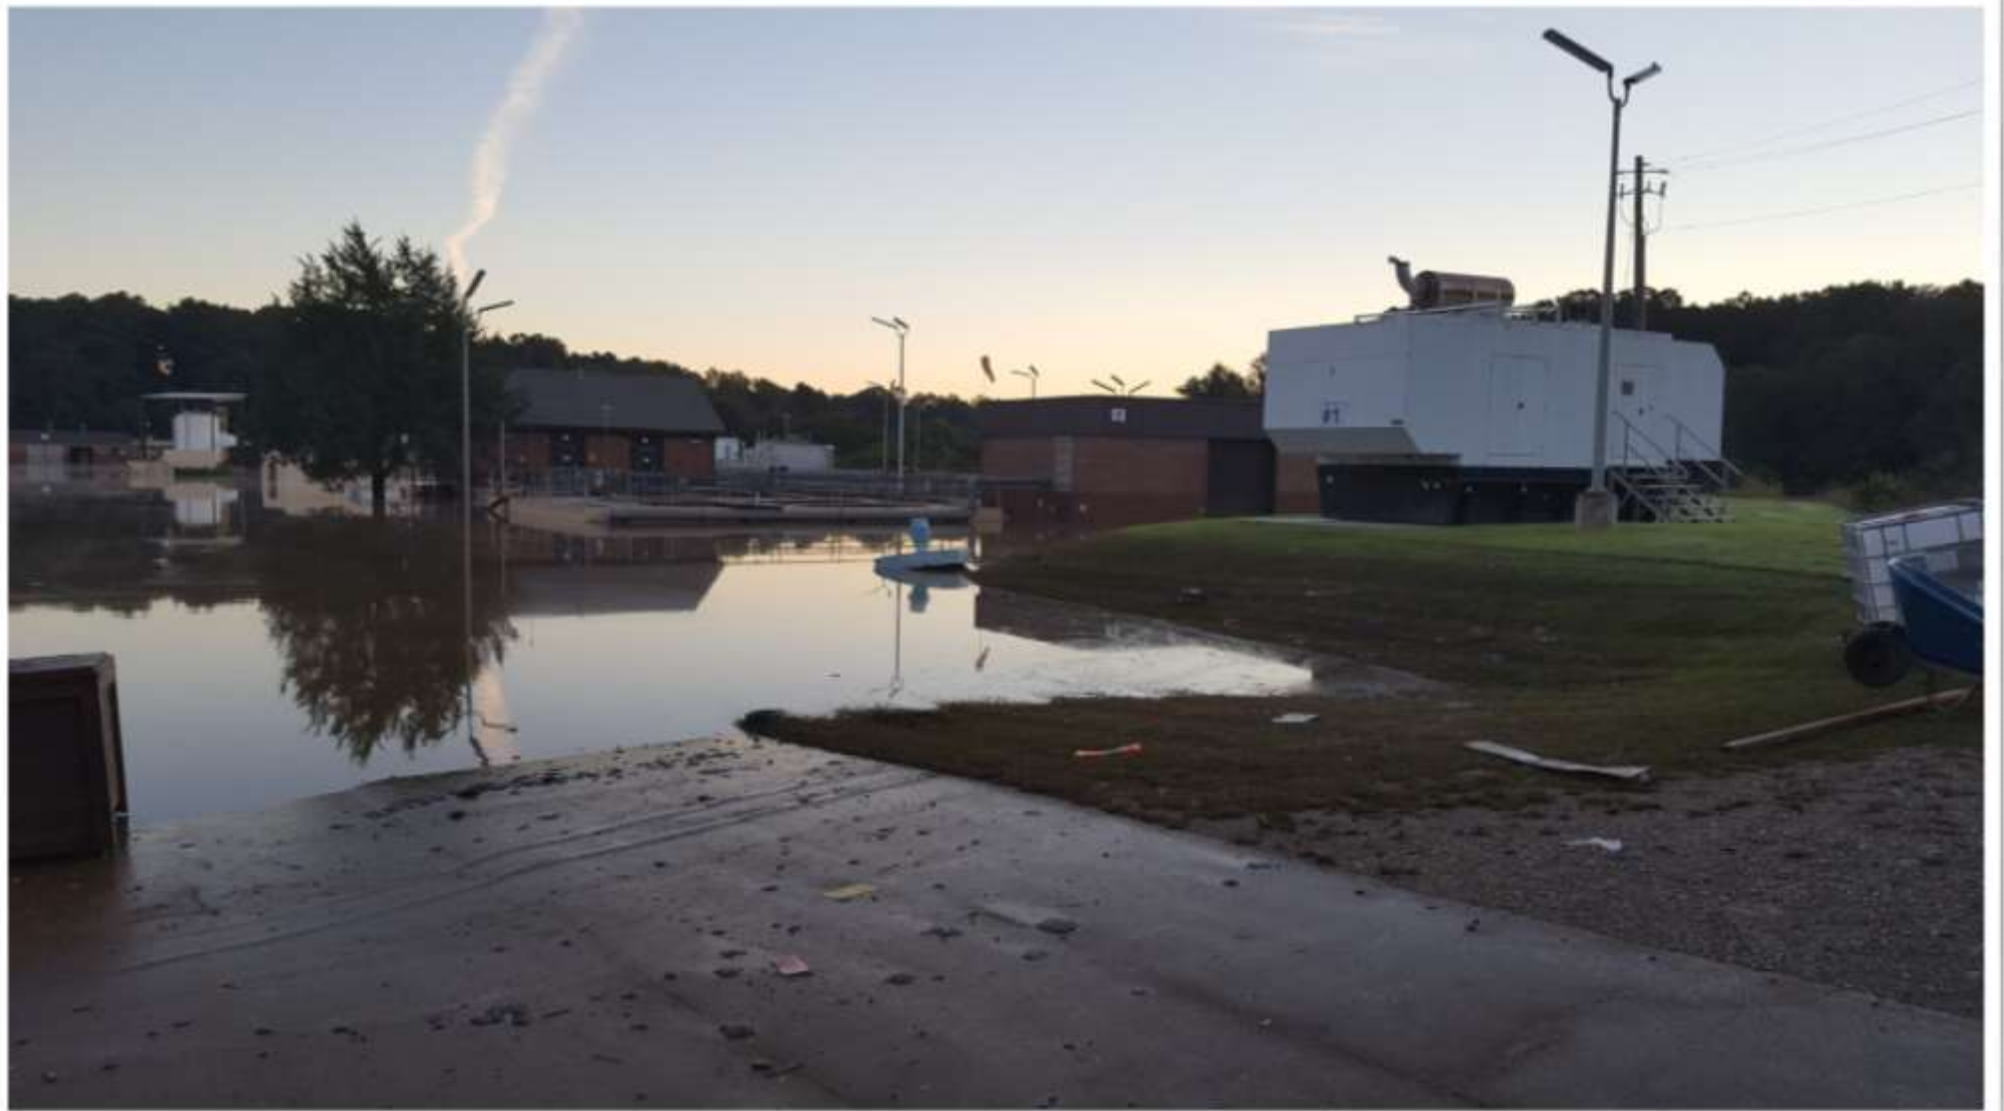
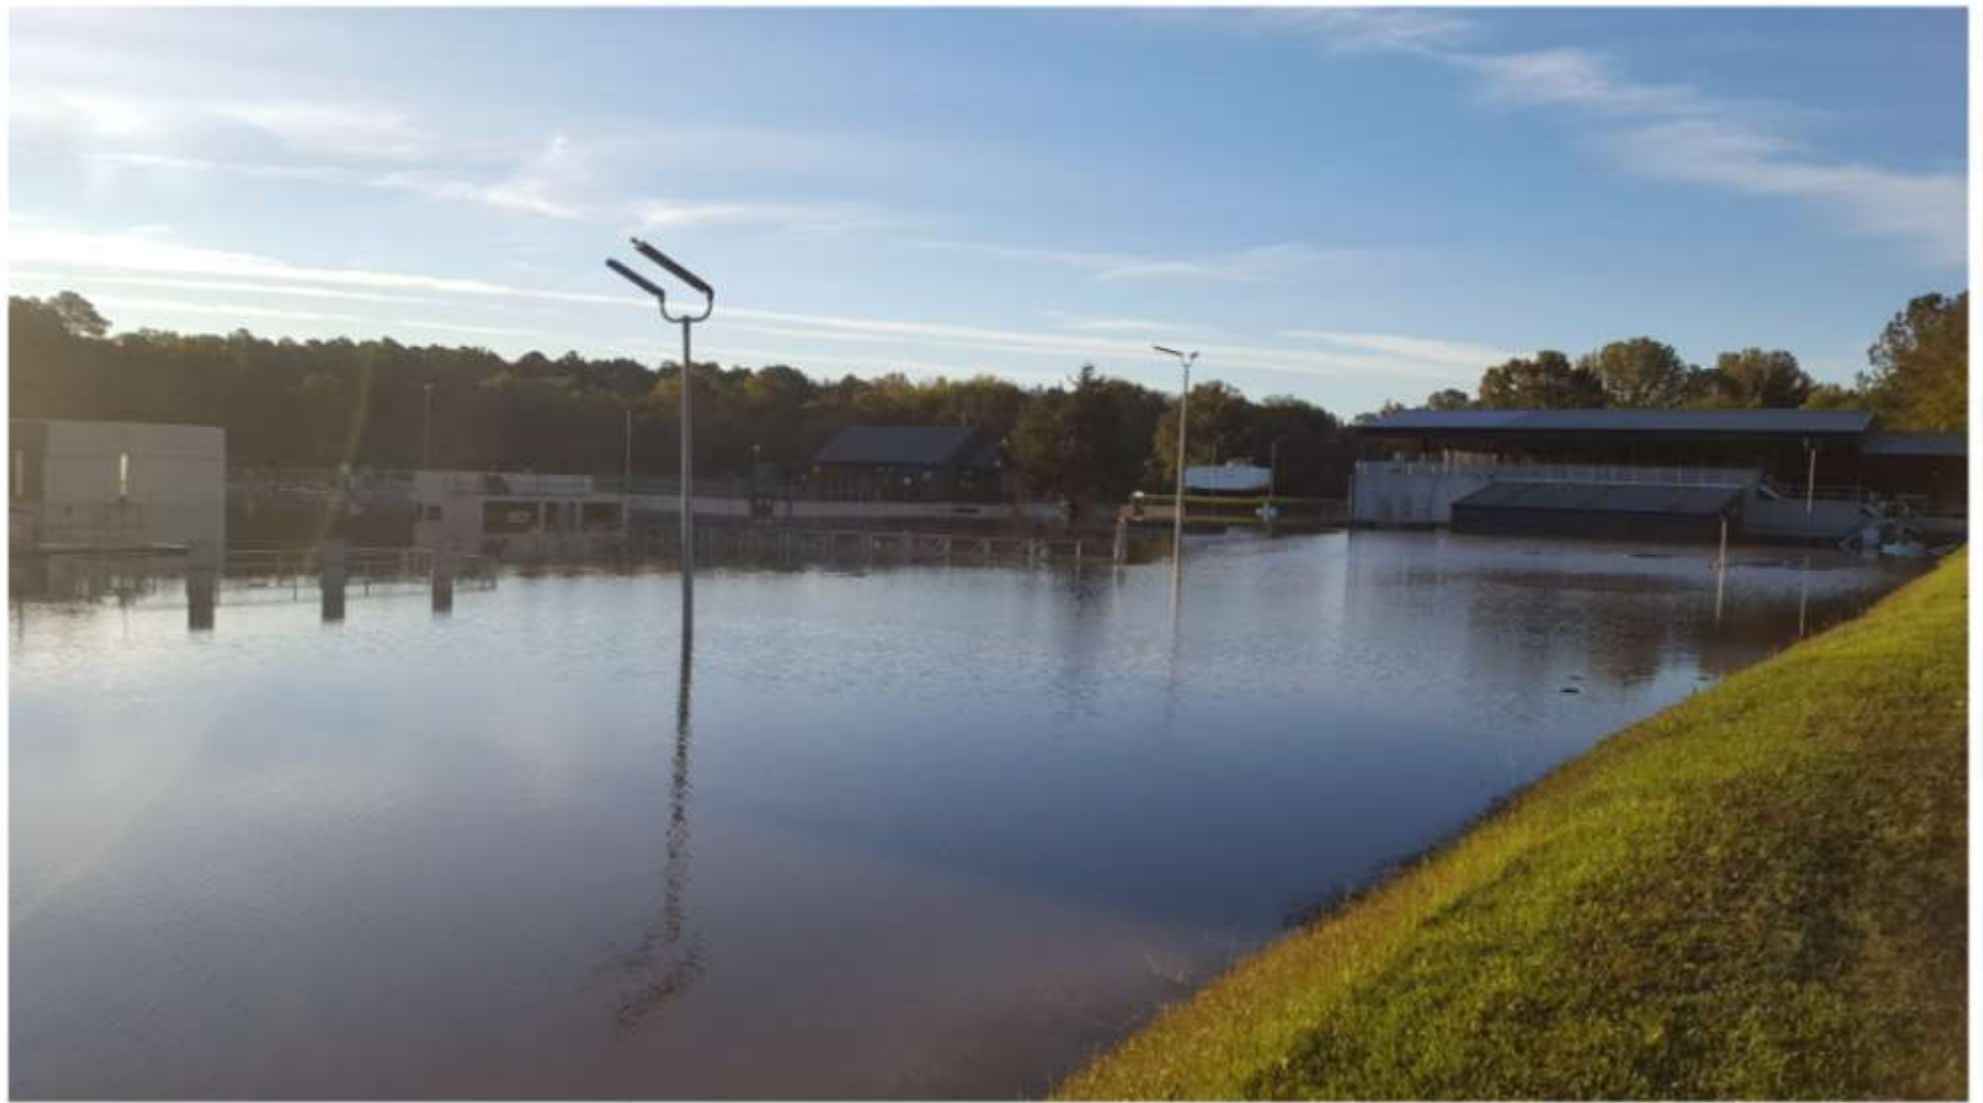
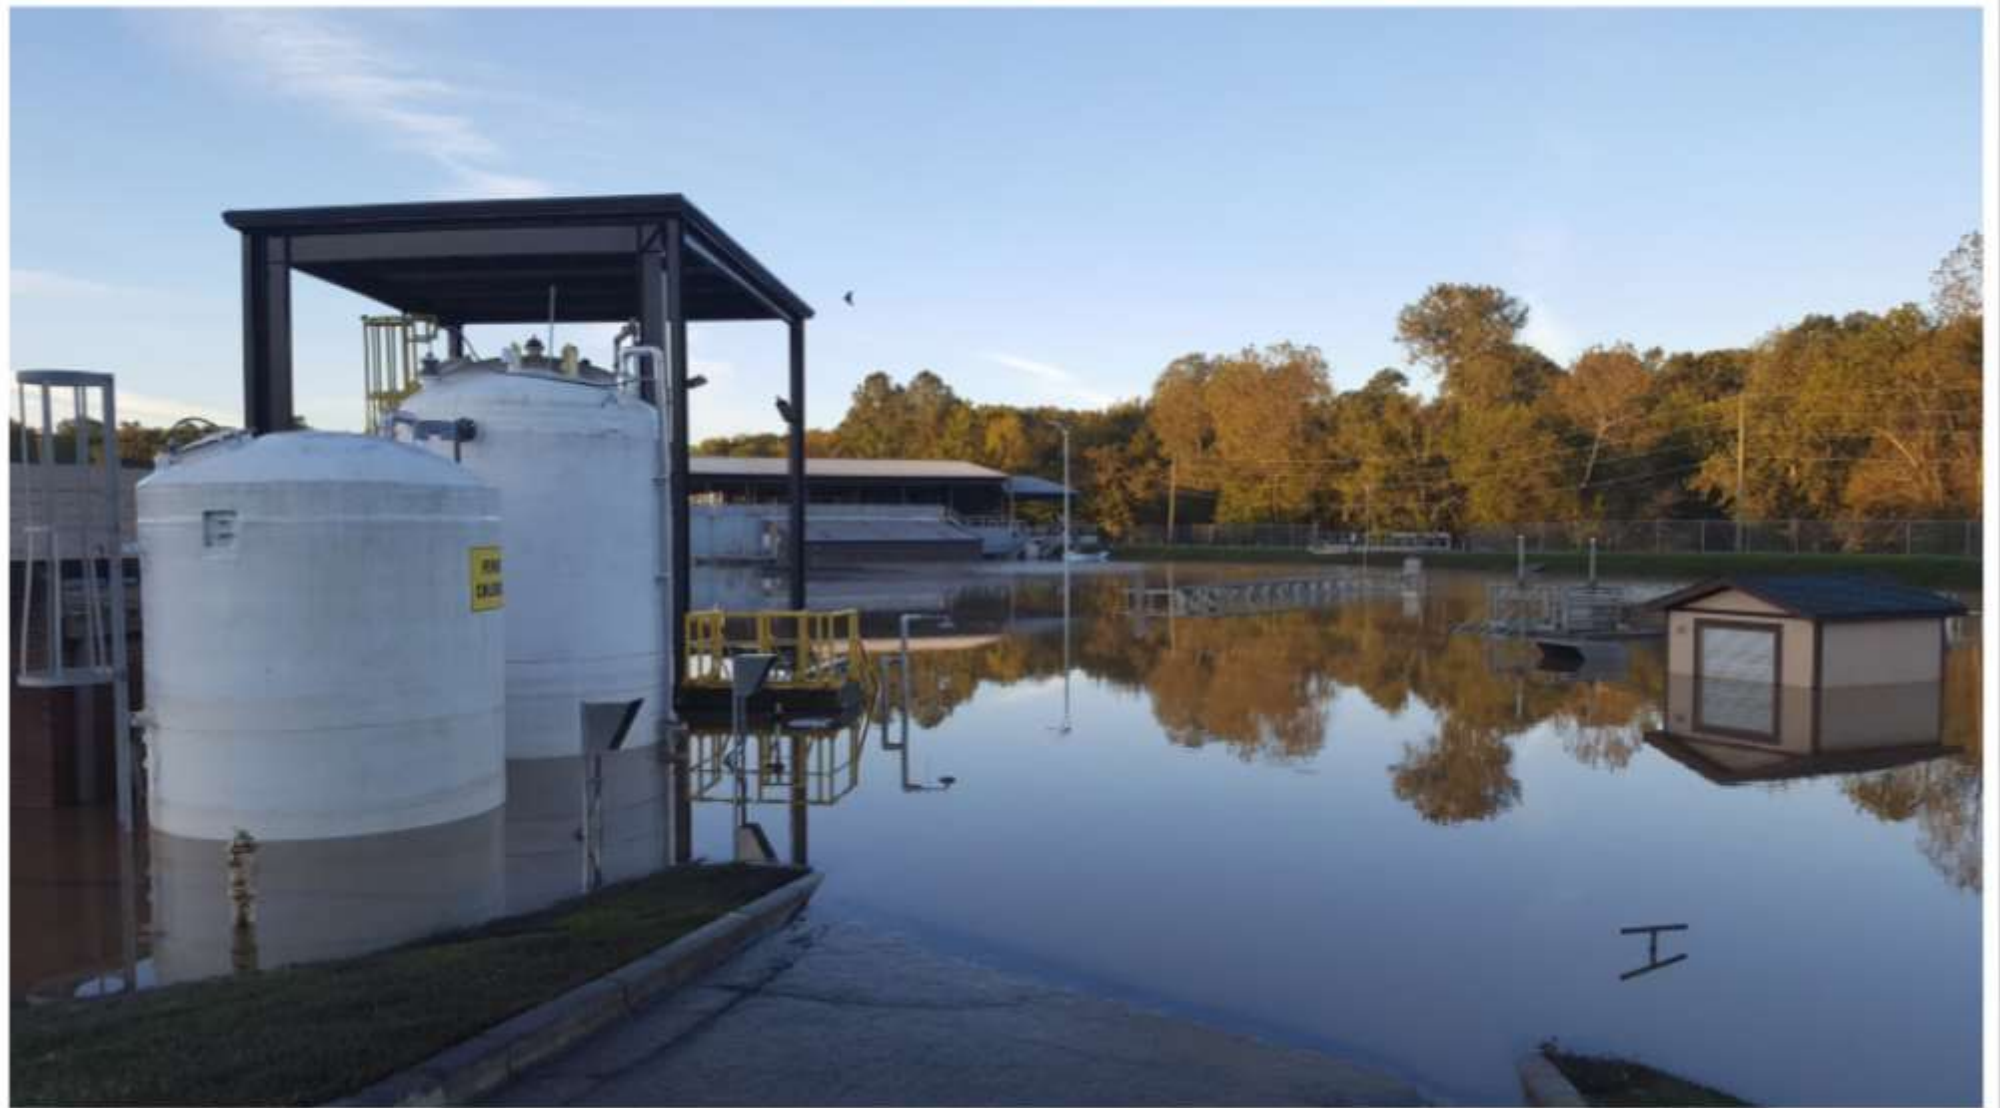
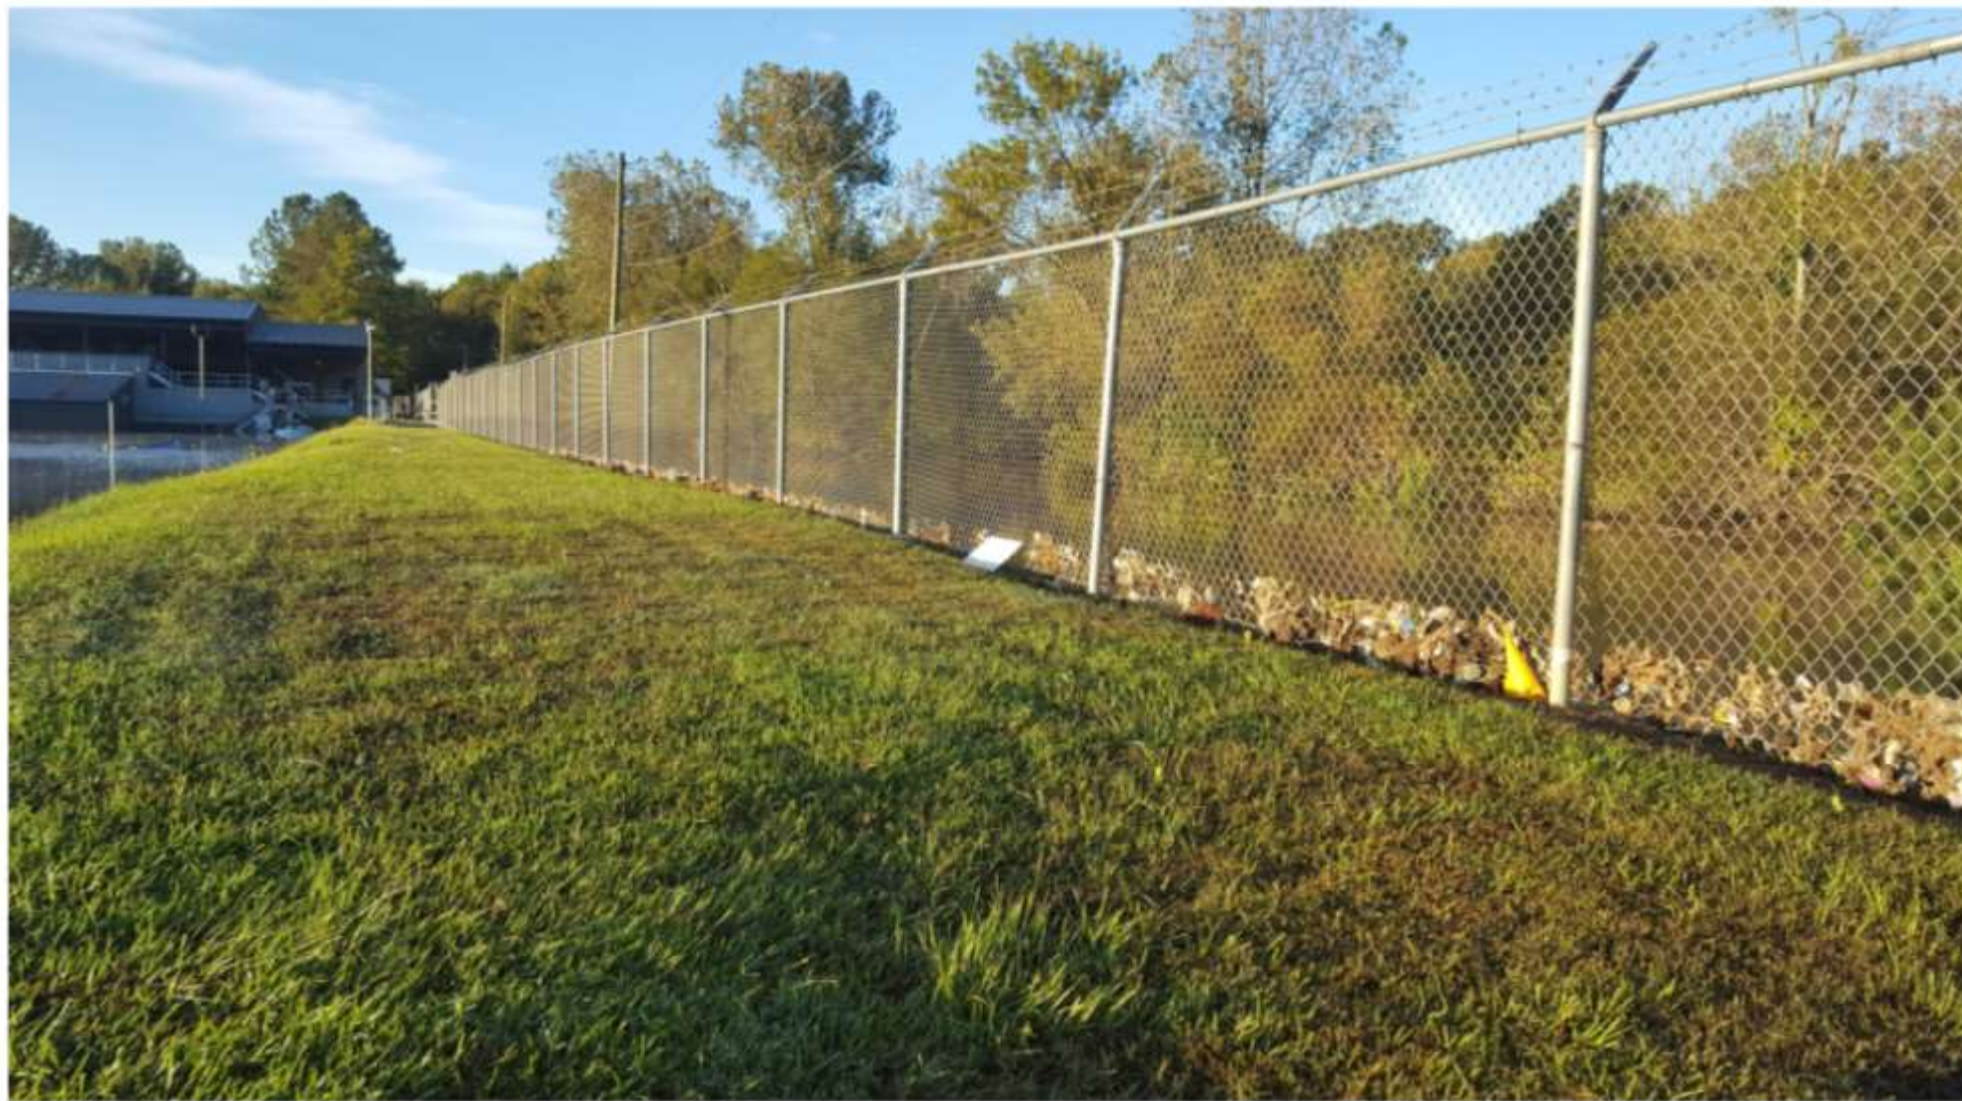
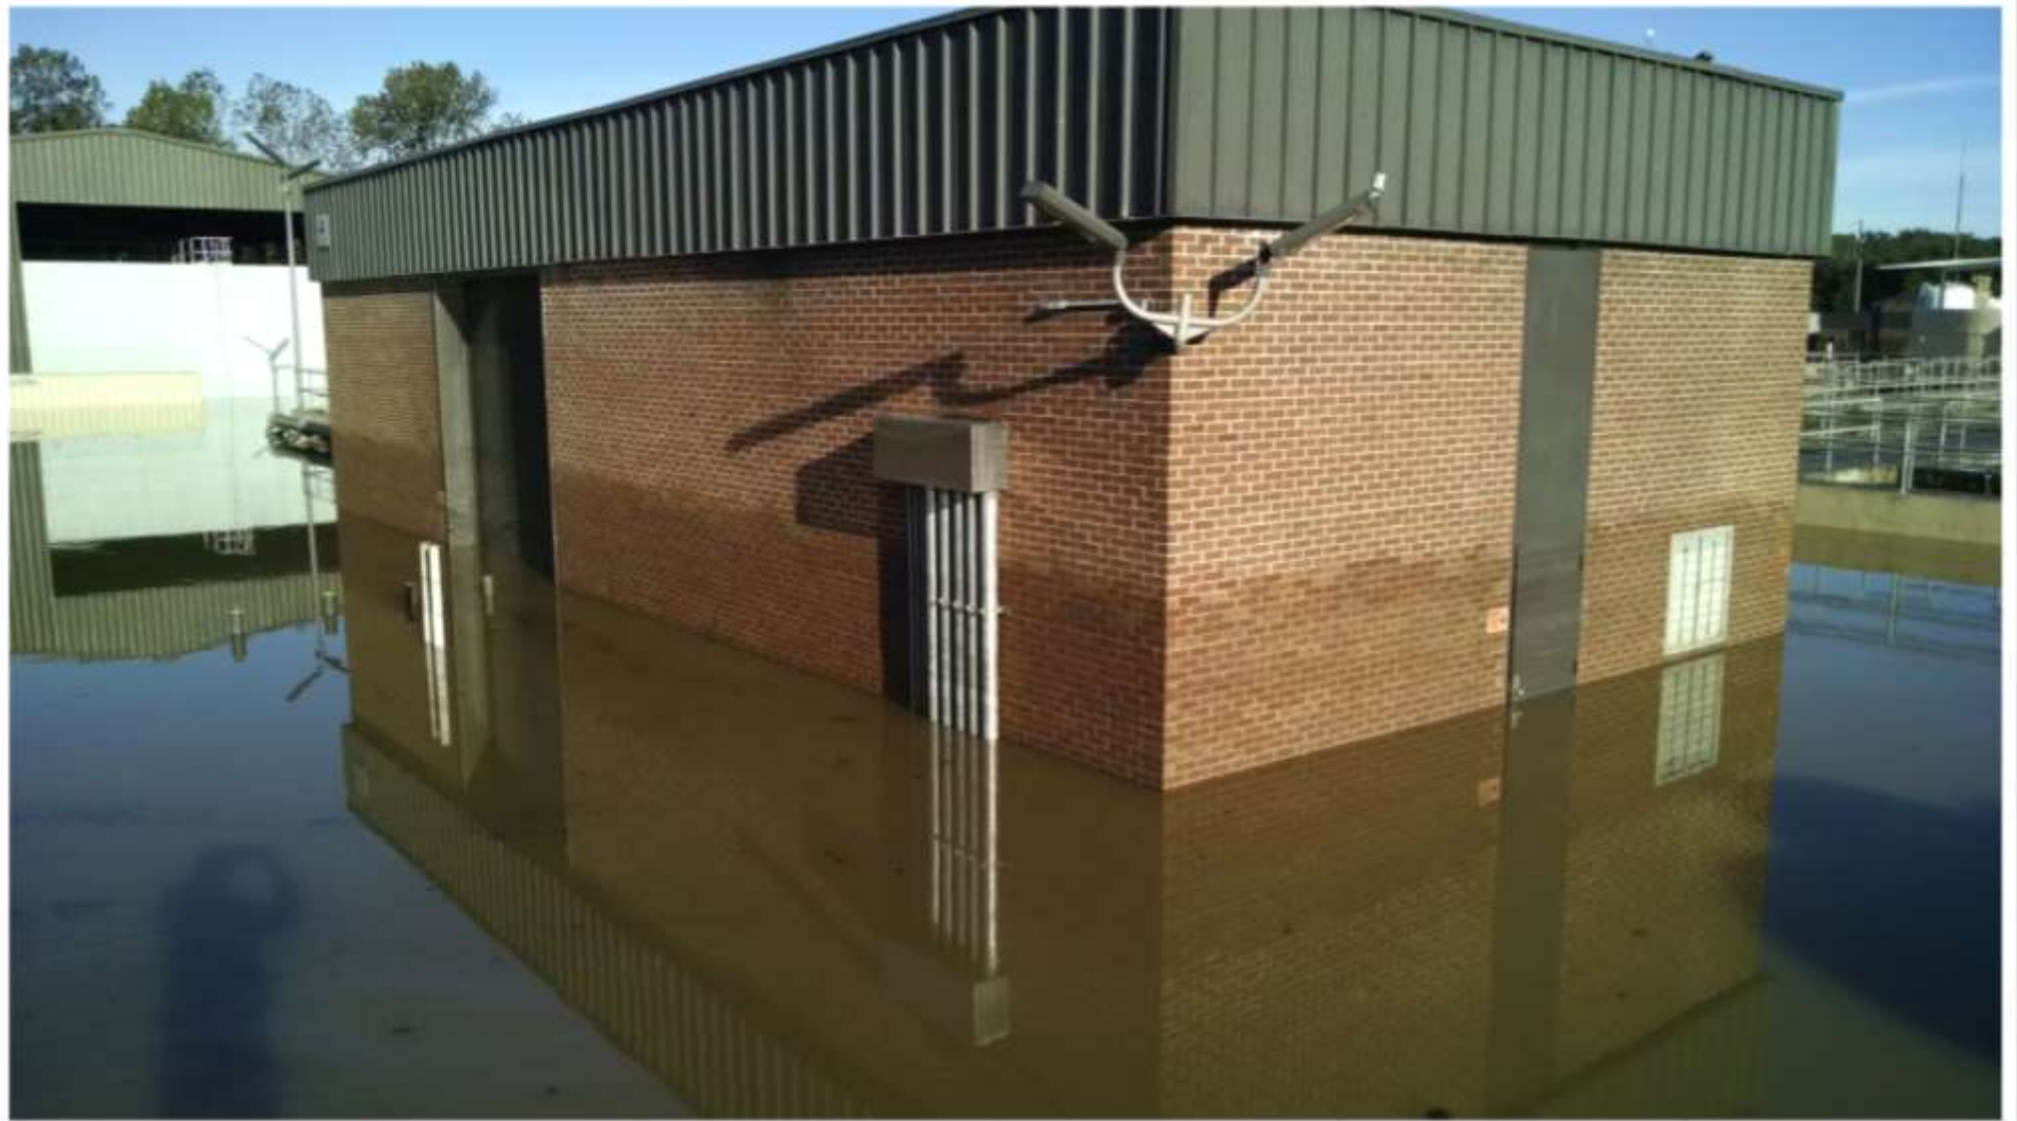
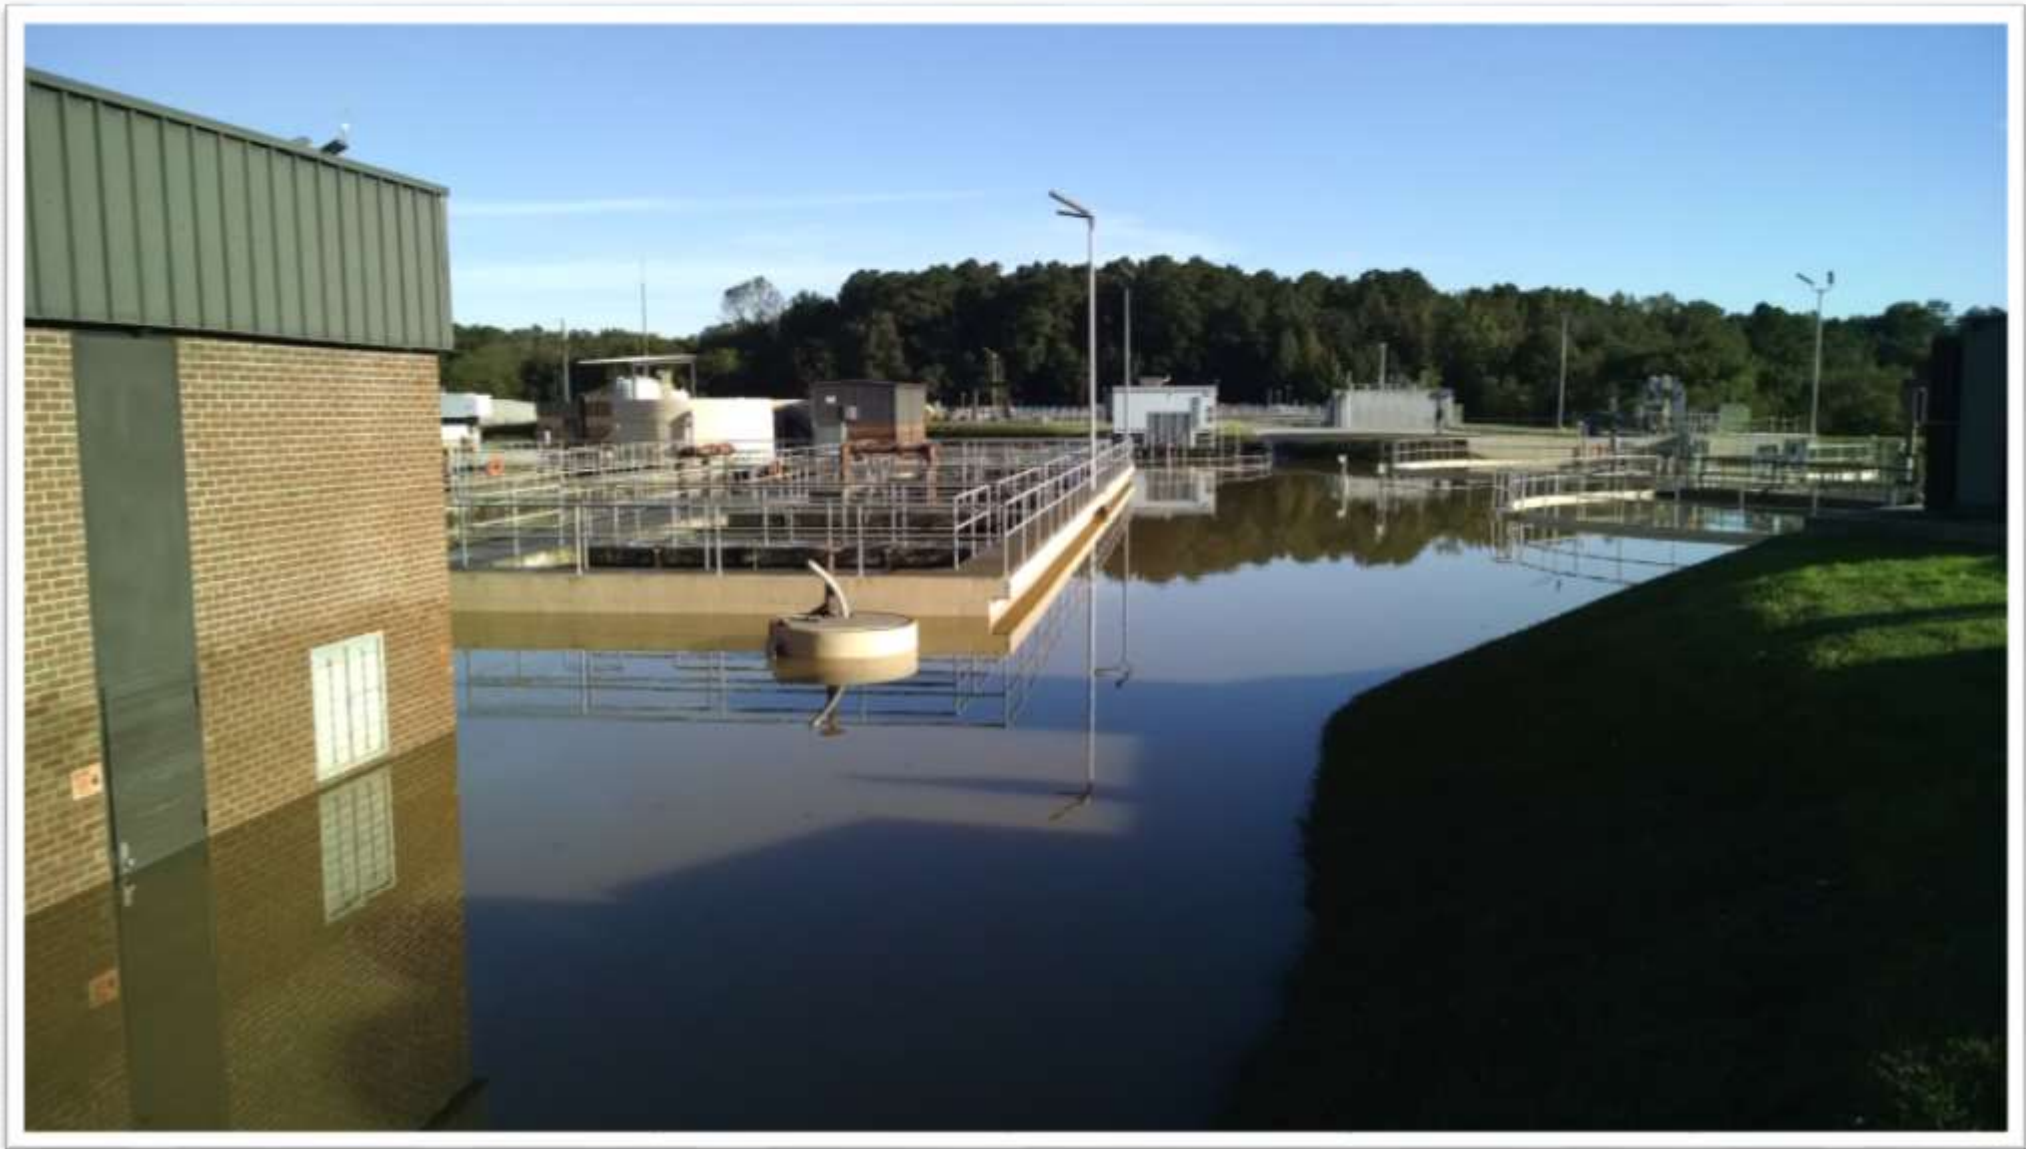
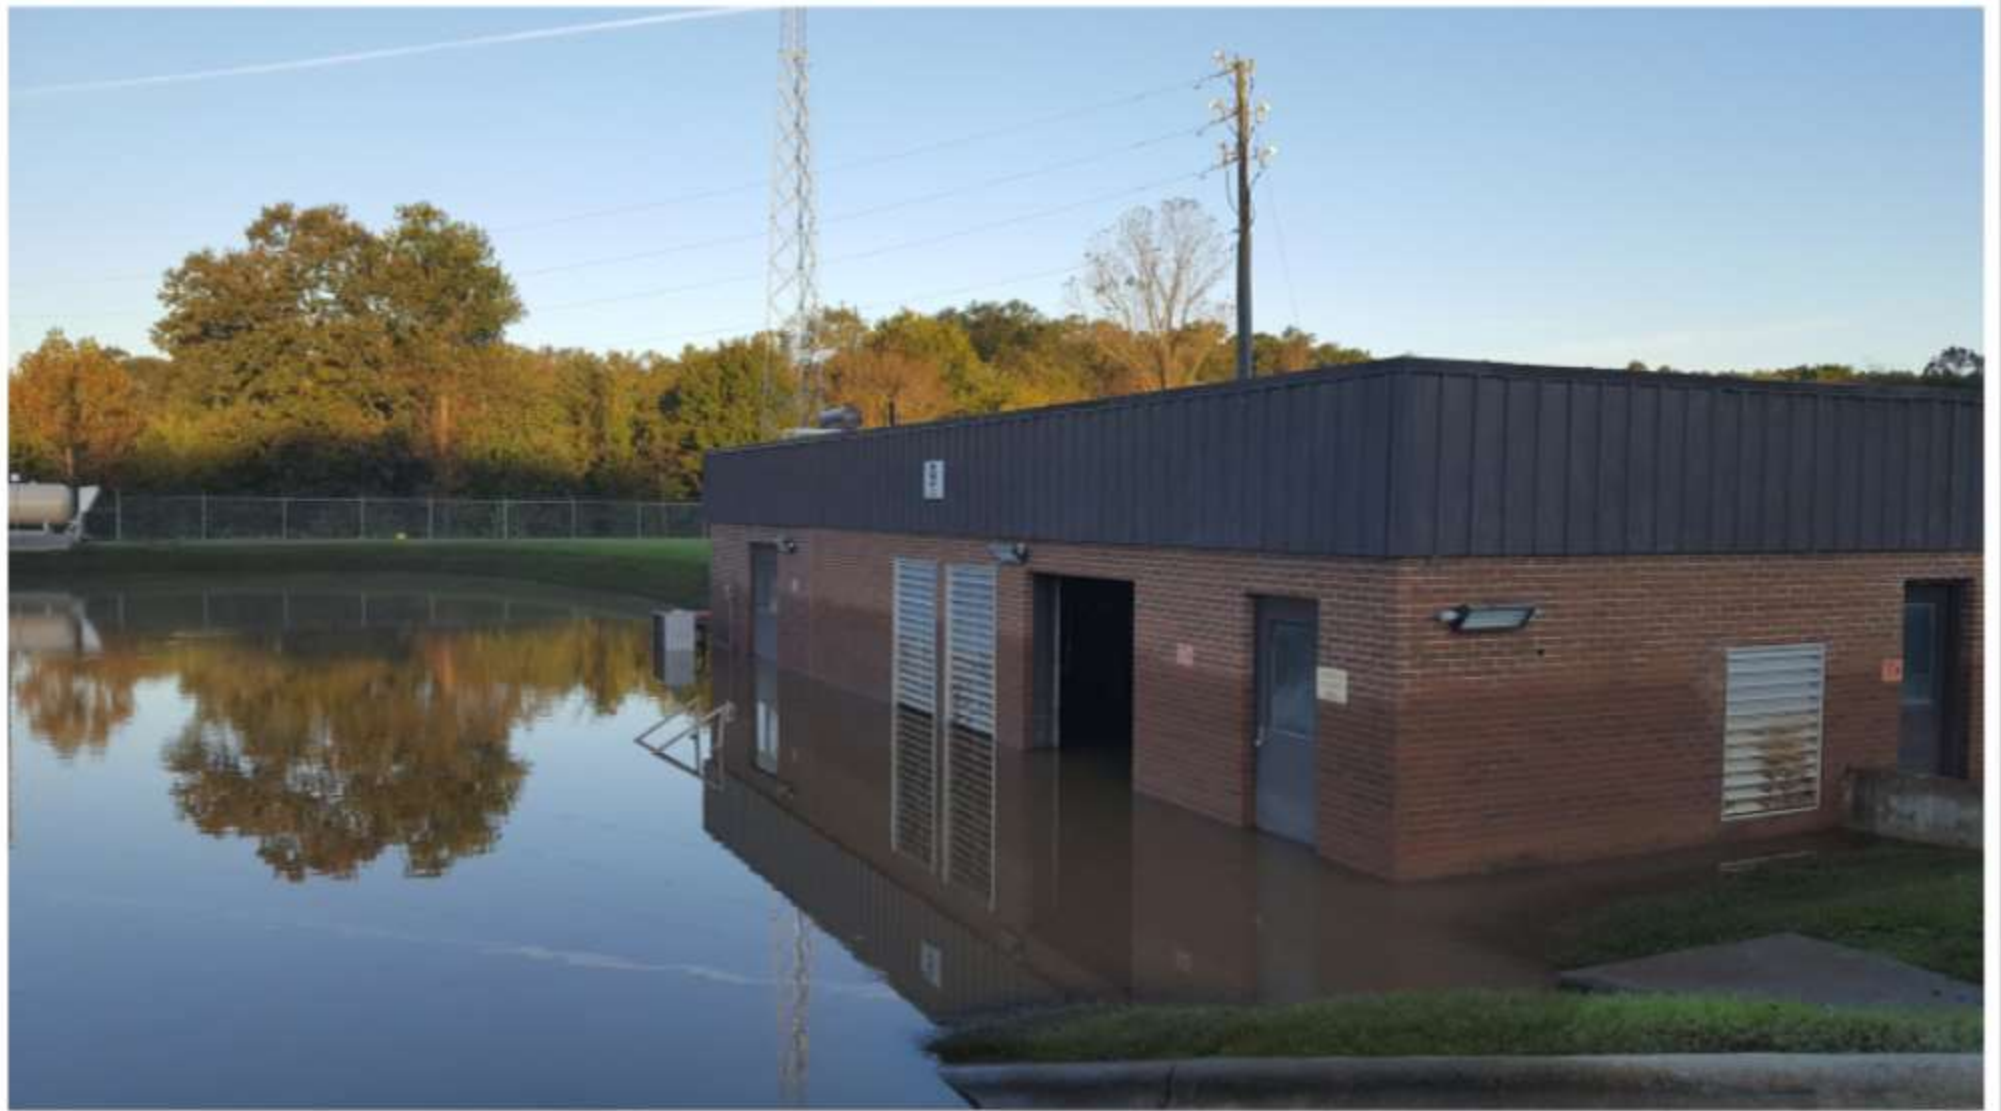
## 16 Hours After River Flood Crest

- 33% of influent pump capacity
- 25% of aeration volume
- 70% of blower capacity
- All clarifiers
- All RAS pumps
- Denitrification filter influent pumps
- Denitrification filters and backwash basin
- 60% of SCADA panels
- Bulk chemical tanks
- Chemical feed pumps
- Operators' building
- Shop and warehouse
